CITY OF ALCOA, TENNESSEE

Americans with Disabilities Act Self-Evaluation and Transition Plan

FINAL VERSION

AUGUST 2019

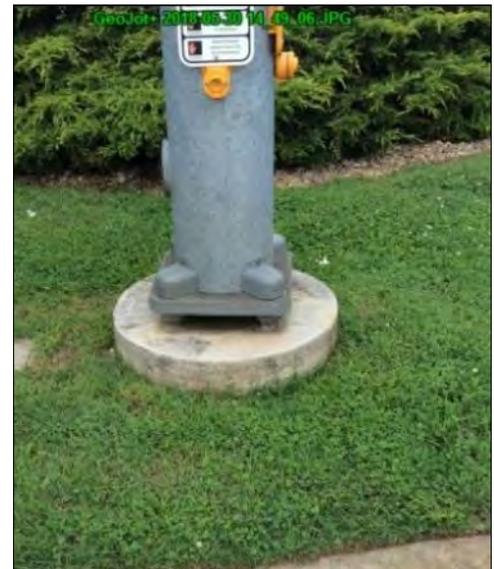
Example of pushbuttons that are not located on an accessible route.

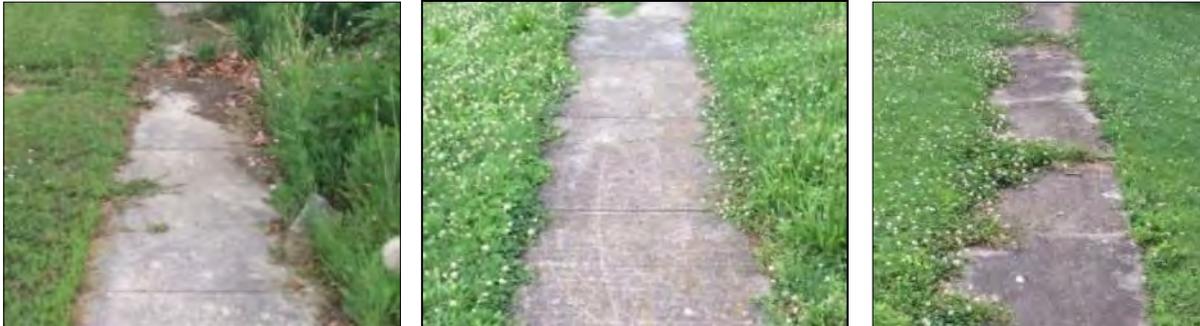
overgrown vegetation. Where the PAR functions as a multi-use pathway, including greenway connection, areas are 8' or more in width. Some 4' wide sections exceed 200' of length with no passing space available other than driveways, which typically exceed cross slope criteria. Issues observed that reduced the sidewalks to less than 48" minimum included overgrown turf and obstructions.

Examples of older sidewalk locations that are typically 36"-42" in width.

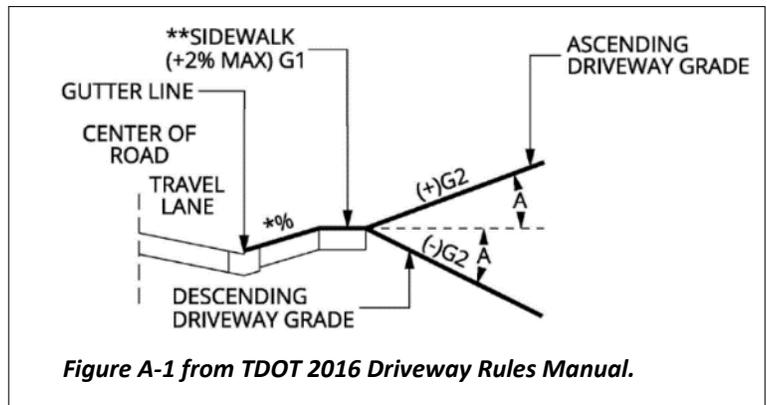
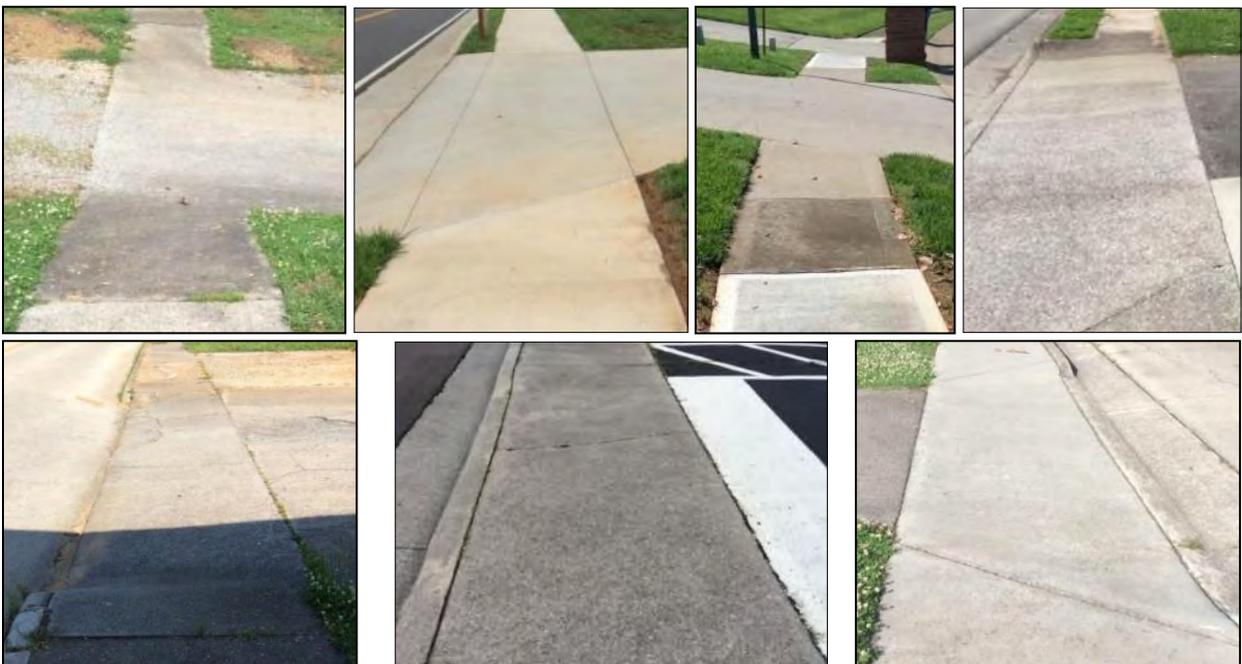
Examples of driveway transitions at the PAR that introduce severe cross slopes and/or vertical elevation changes.

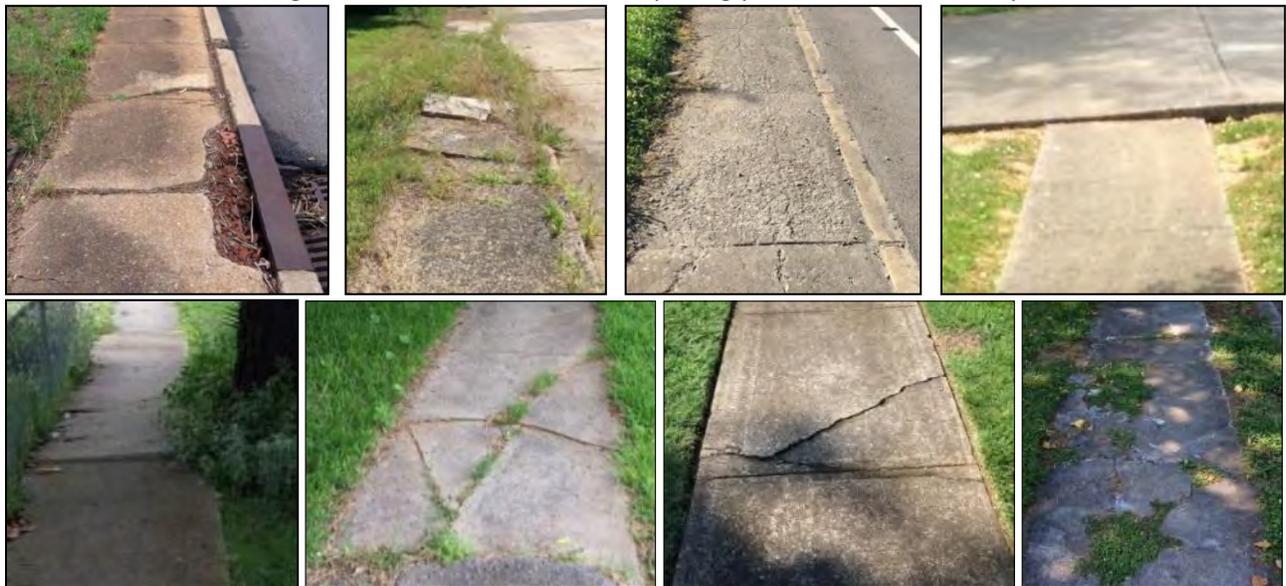
Examples of displacements, separations, and pavement in poor condition in need of maintenance/replacement.

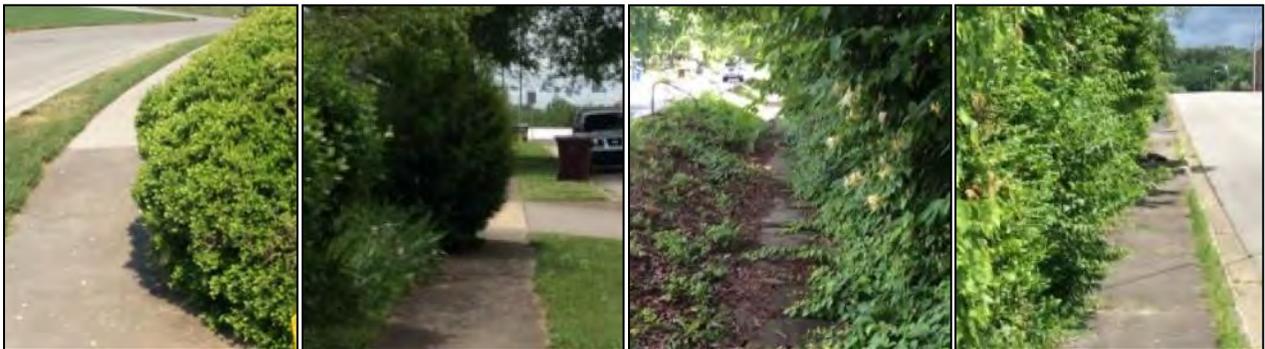
Examples of overgrown vegetation that reduces the PAR width to less than 48".

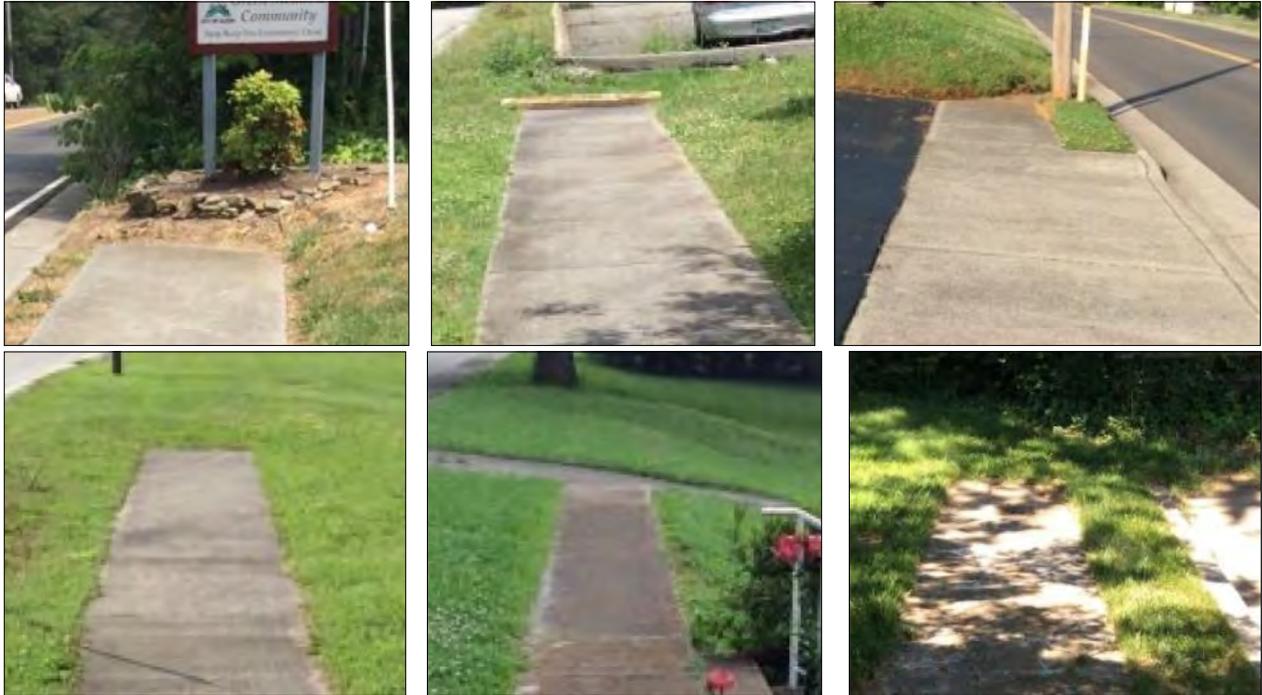
If a PAR is provided but it abruptly ends at the end of a block without any advanced warning or signage, it can be extremely problematic for a wheelchair user. Often the sidewalk width is not adequate to permit a wheelchair to turn 180 degrees. In some cases, a wheelchair user, upon recognizing the PAR is ending ahead, will opt to attempt to utilize a driveway to access the adjacent street. If the slopes of the driveway are steep when compared to the PAR, this turning maneuver could cause a wheelchair to tip over. If there is not a driveway available, a wheelchair user will need to backtrack to the nearest access point and find an alternate route.

Examples of PARs that end distant from an intersection.

Where the PAR terminates outside the normal visual distance from an intersection without a crossing or other direct connection to another PAR, consider placing advanced signage that indicates the PAR will dead end ahead and suggest a crossing location that provides a continuous PAR (see example to the right). These signs should be placed where they will be seen as soon as possible and minimize backtracking. Drainage issues should be resolved when sidewalks are replaced and typically are corrected as part of improving running and/or cross-slope issues. Where railroad tracks exist, tracks should be removed when the PAR is replaced if not in use. If in use, ensure that coordination with the owner occurs to install the required detectable warnings and the flangeway gaps comply. For the sections of sidewalk connecting the PAR to the street, these segments of sidewalk should either be removed entirely or have a full height curb installed at the street to provide a detectable edge. Where existing segments provide a curbed edge and provide access to residences from vehicles parked on the street, ensure that the curb is maintained during street and/or sidewalk projects.

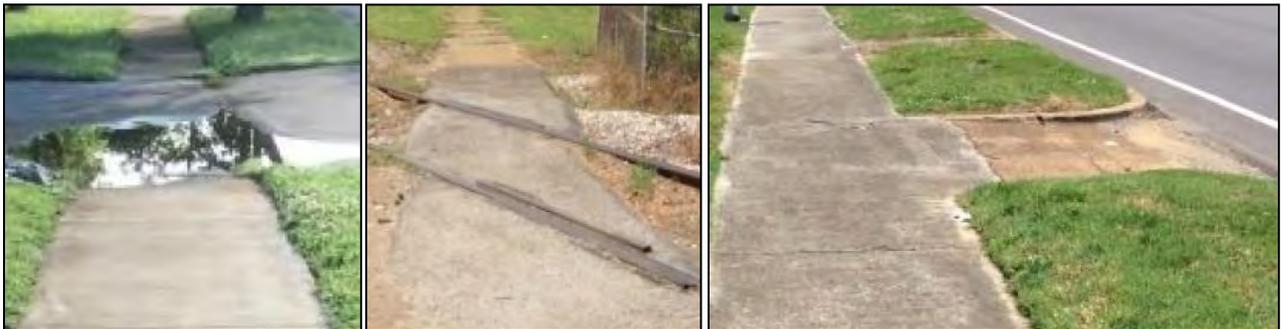
An unusual issue, though localized to a few locations such as Hall Road, is the presence of short segments of sidewalk perpendicular to the PAR that connect the street to the PAR. Though not considered part of the PAR and have no requirement to be compliant, often these segments are ramped and provide a flush transition to the street that could be hazardous to pedestrians with vision impairments since they “act” very much like a curb ramp. These segments essentially create a crossing point on the street that is not intended and no detectable warnings are provided to alert blind pedestrians to the danger.

Examples of other issues observed in the City to address. Note perpendicular sidewalk segment to the right that “acts” like a curb ramp and could be especially hazardous to blind pedestrians.

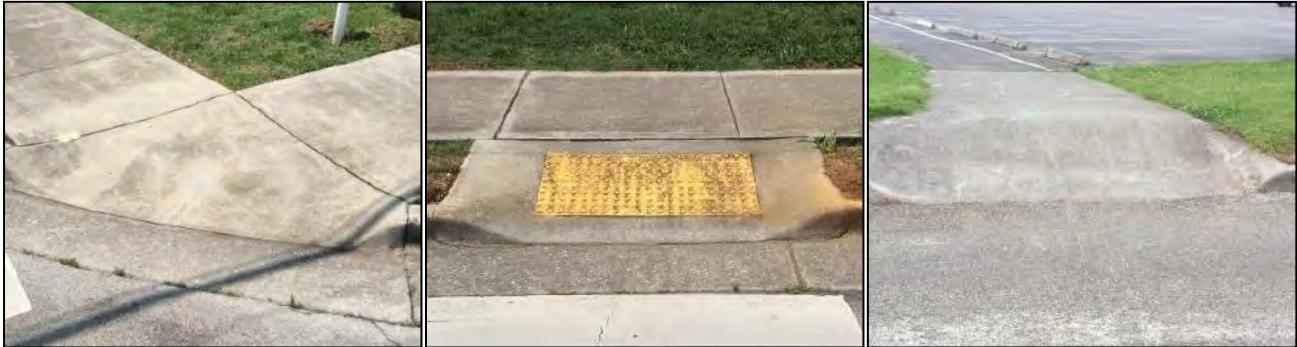
As noted above for ramp width, the number of ramps that were not in compliance with the 8.33% maximum running slope was relatively small though much higher than the number of ramps with non-compliant width. To provide a compliant 8.33% maximum running slope for a perpendicular ramp for a typical 6" curb, the distance required from the grade break to the top of the ramp is approximately 6 feet, at which point a minimum 48" top landing/TS is required. In many areas the running slope complies but there is no landing or TS provided.

Curb ramps with excessive running slopes, typically severe slopes that exceed 10%. These ramps also often exceed the counter slope requirements and have no level TS.

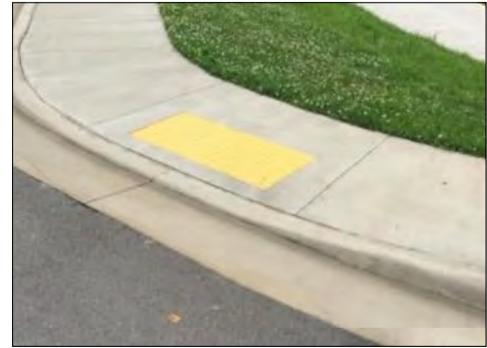
Non-compliant turning spaces/landings are caused primarily by construction of the wrong kind of ramp in a space that is inadequate to provide the required slopes and dimensions. In most cases the only means to provide a compliant turning space/landing is to reconstruct the ramp and use a parallel configuration. In areas where there is adequate space that we simply not used in the original construction, reconstruction to the extent needed to provide compliant dimensions and slopes is needed.

Example parallel curb ramp that lacks a compliant turning space.

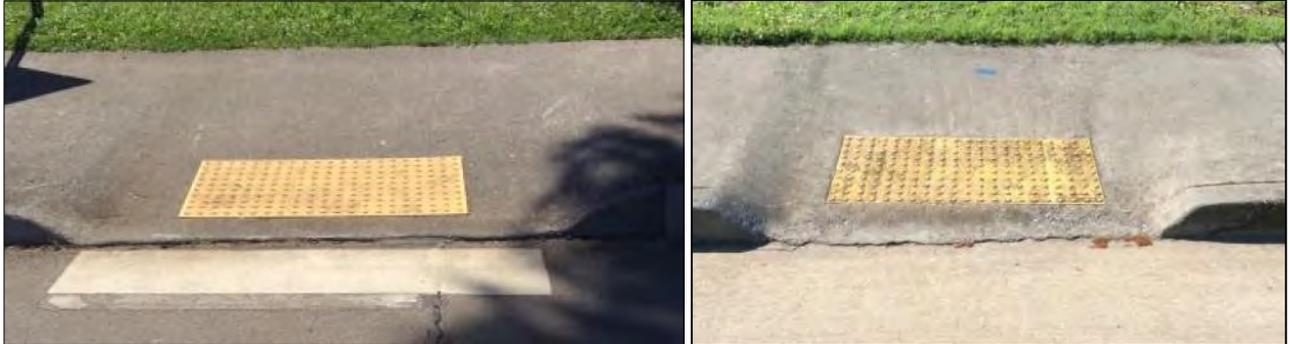
Example of curb ramps that have non-compliant flare slopes.

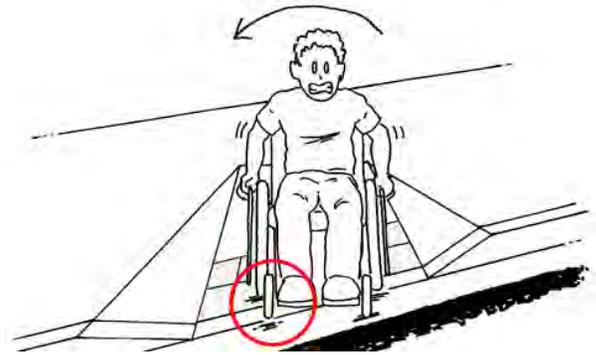
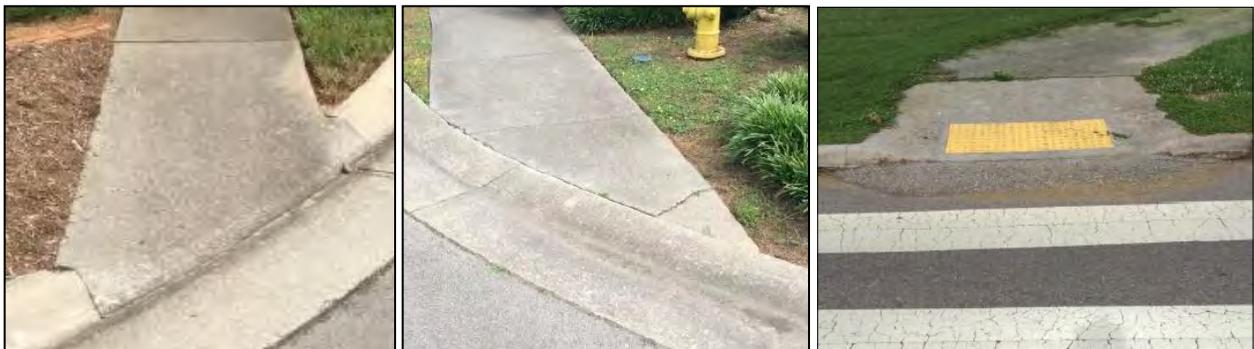
Example of curb ramps that do not provide the required perpendicular grade break or clear space.

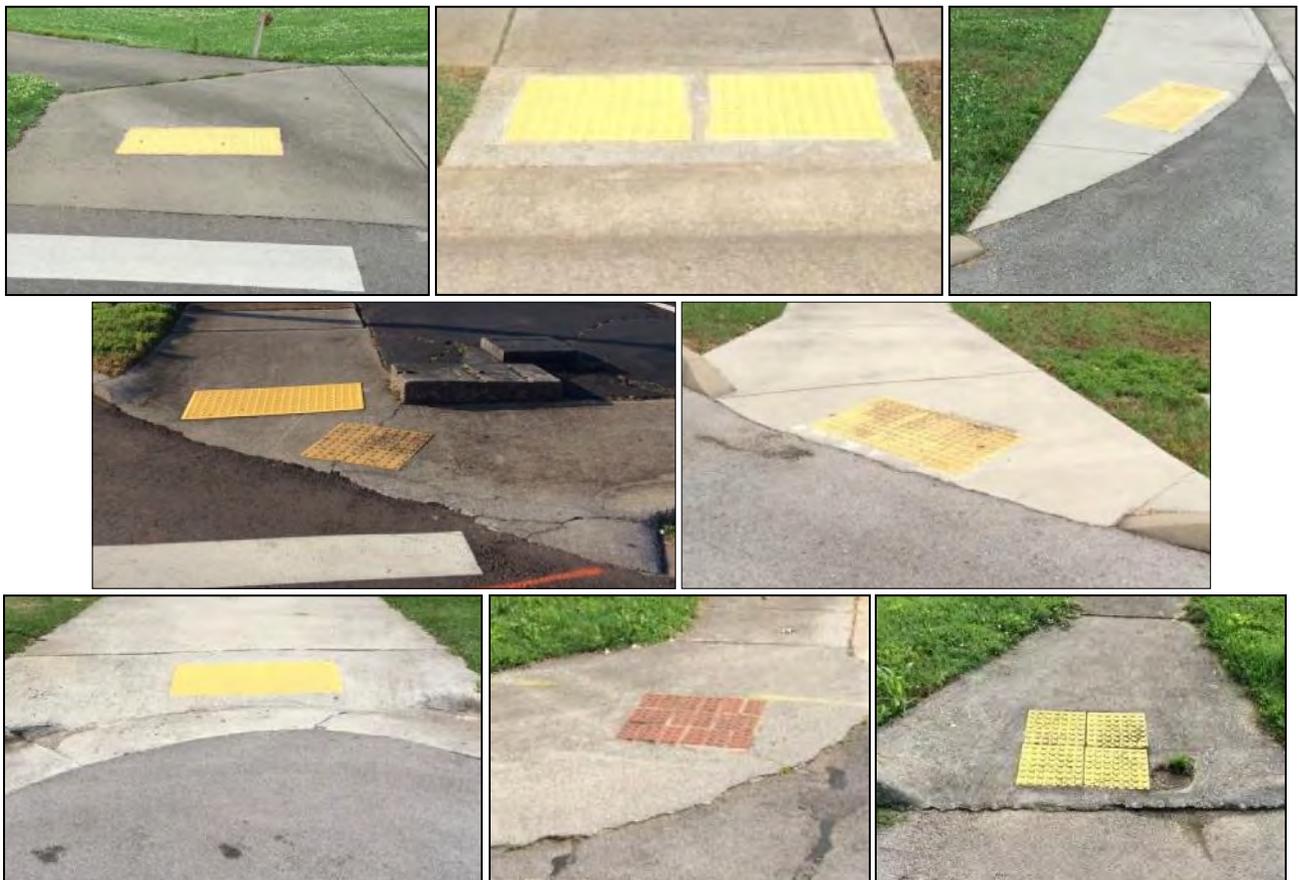
Example of curb ramps with detectable warnings that are not full width of the ramp.

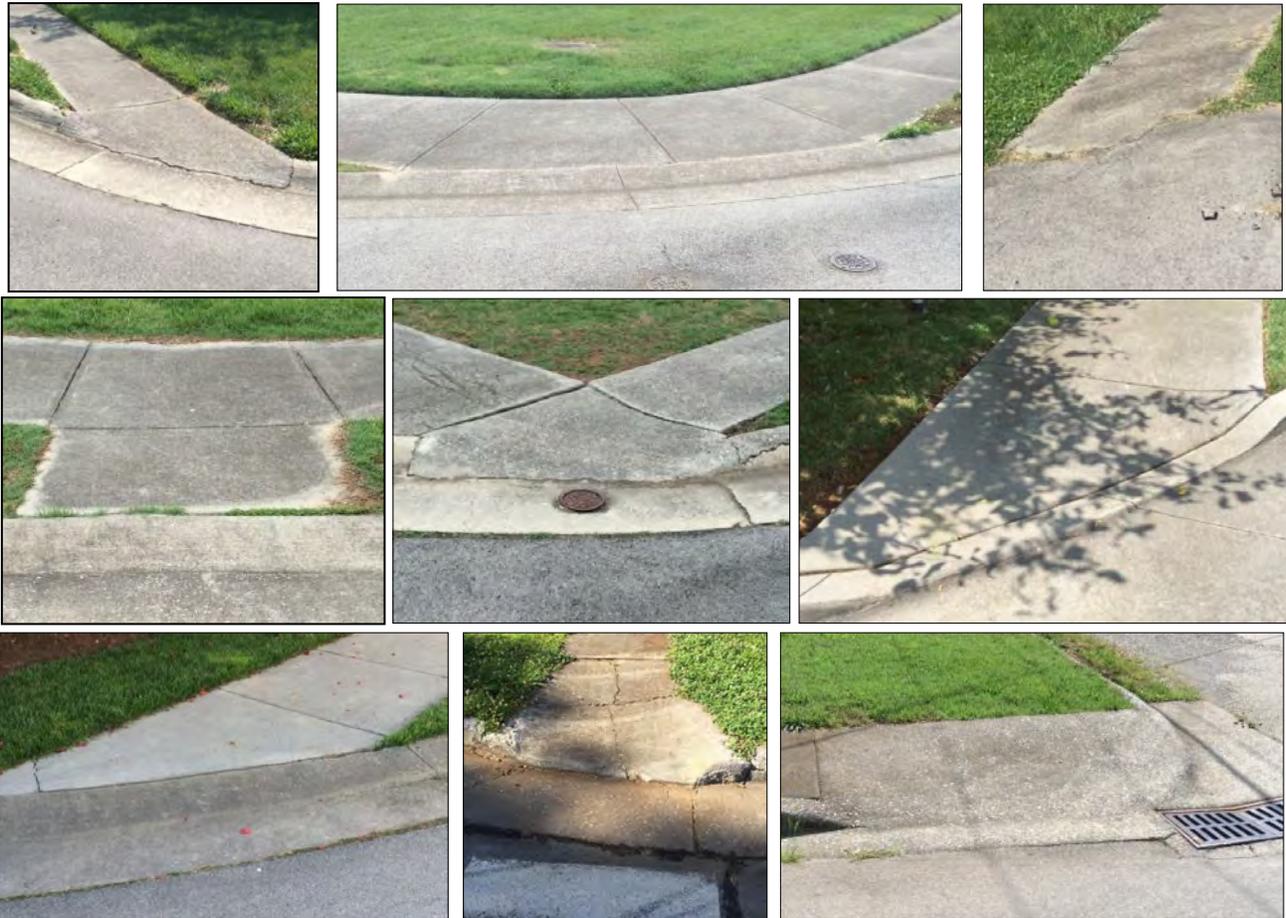
Curb ramps that do not have DWs, including some with fairly recent reconstruction.

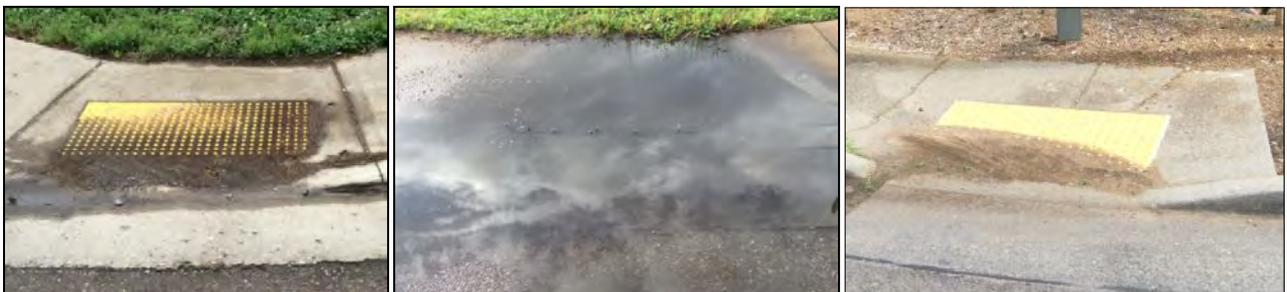
Examples of curb ramps with drainage issues and/or evidence of regular ponding, with sediment deposition.

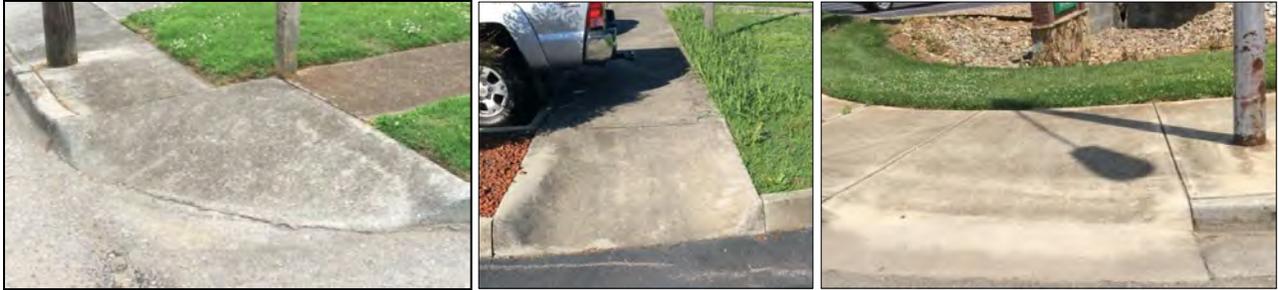
Examples of curb ramps with obstructions at turning spaces, on the ramp, or immediately adjacent to either.

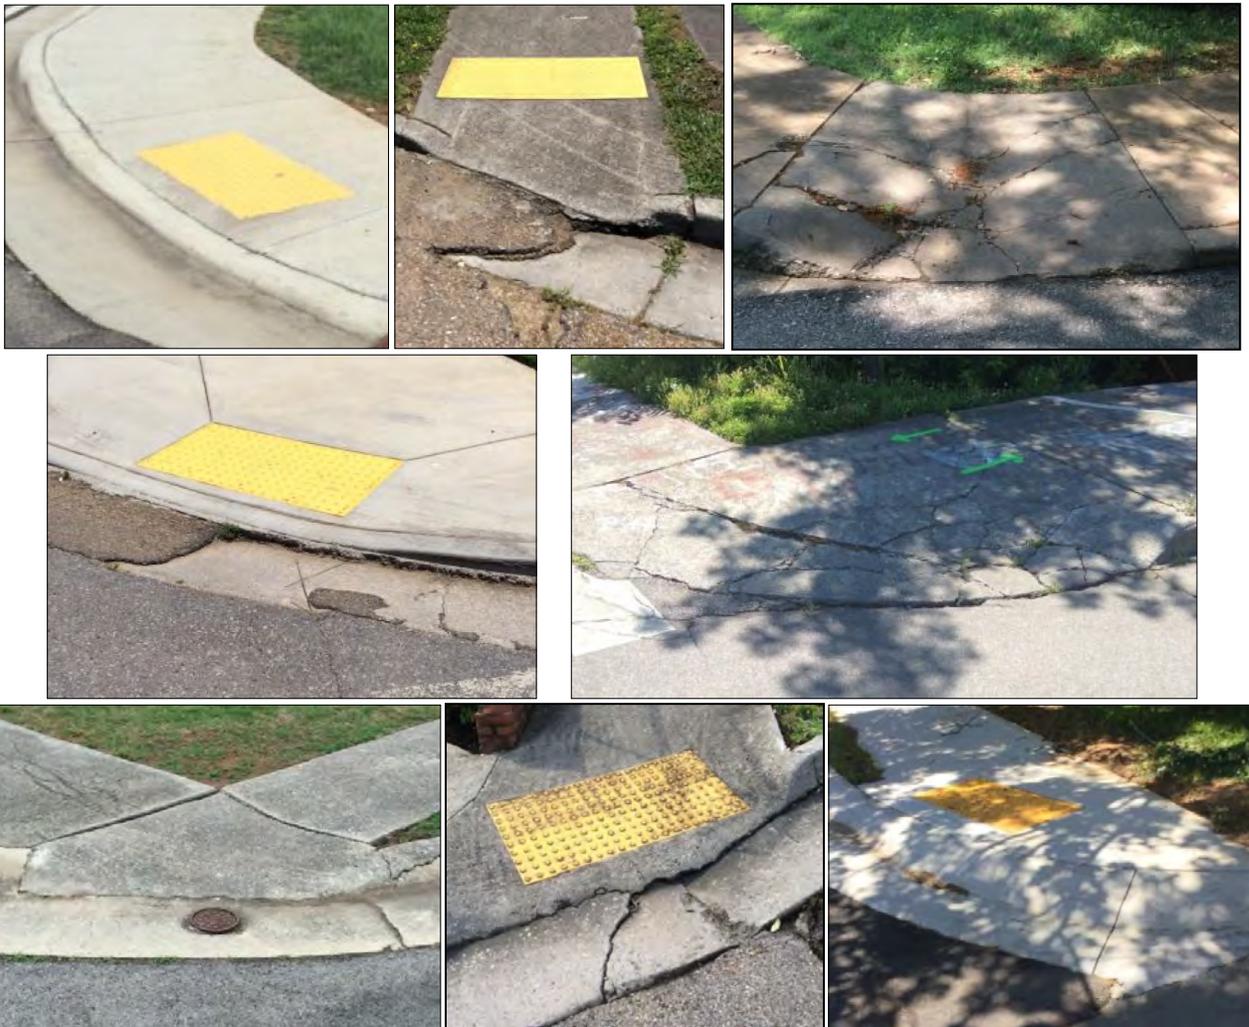
Examples of curb ramps with vertical discontinuities that exceed ½" at the curb, on the ramp, or the TS.

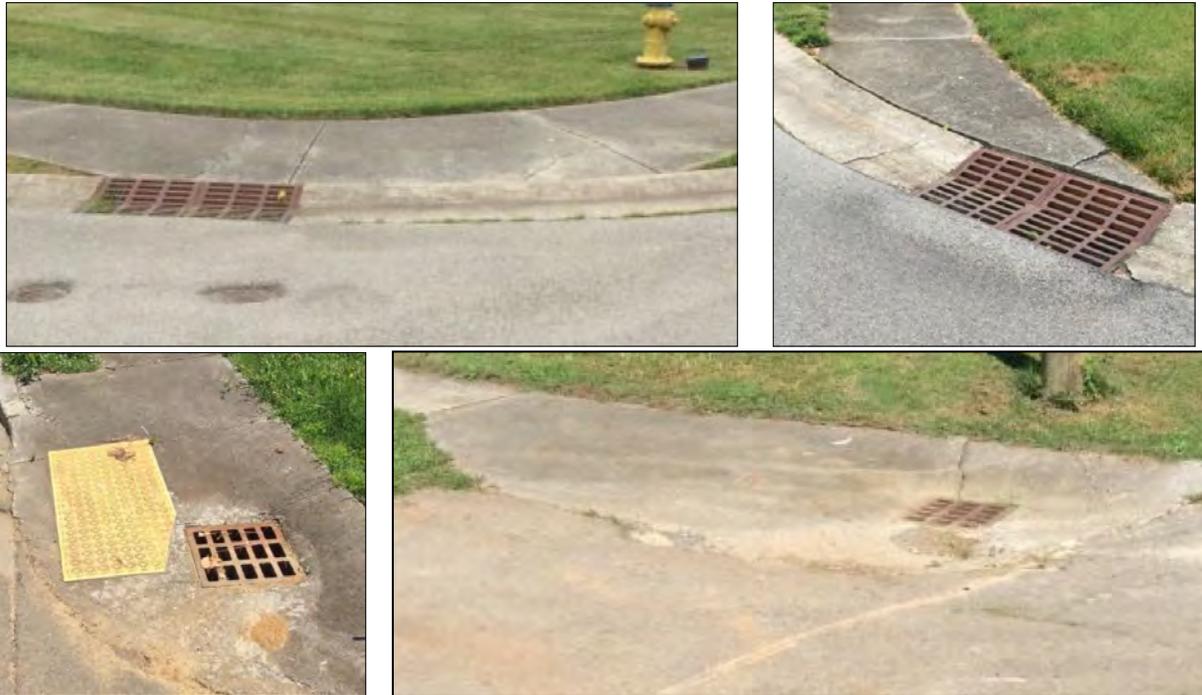
Examples of curb ramps with horizontal opening greater than ½" on the ramp or the clear space.

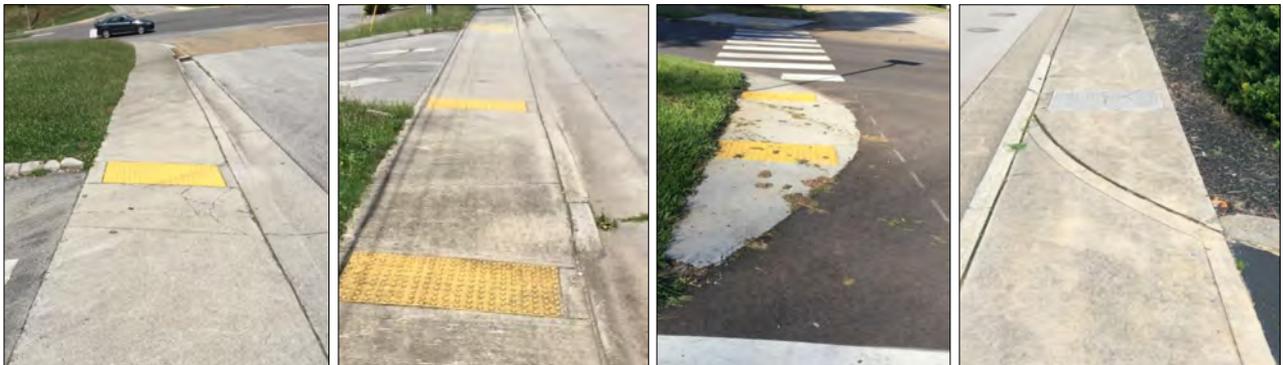
Examples of curb ramps at commercial driveways, with an adjacent PAR that provides no detectable curb edge, or poor contrast. Note that some examples shown may have multiple issues.
