CITY OF ALCOA, TENNESSEE

Americans with Disabilities Act Self-Evaluation and Transition Plan

FINAL VERSION

AUGUST 2019

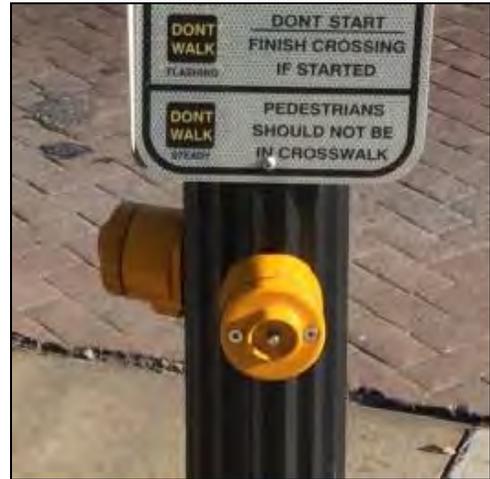
- Most locations had signage present but few were compliant with current requirements.
- Most pushbuttons met the requirement for less than 5 lbs. of operating force. Several were located below 42". Most were older units with small recessed buttons do not meet current requirement for operable parts to be operated with a closed fist and/or being 2" minimum in diameter.

Example of non-compliant pushbutton operable parts

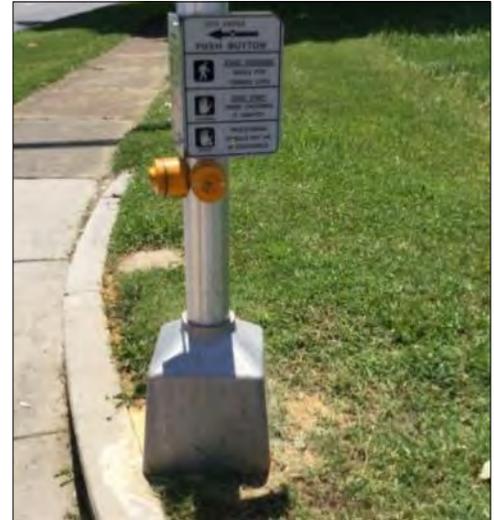
- A majority of pushbuttons were non-compliant for distance from curb.
- Nearly all locations with more than one crossing direction had pushbuttons located on the same pole.

Example of pushbuttons on shared pole

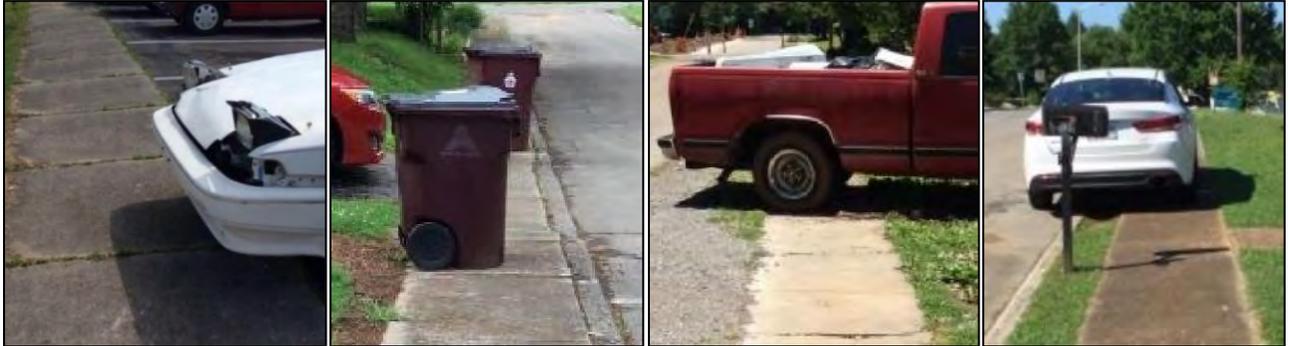
Temporary obstructions include cars in parking lots overhanging the PAR, trash and recycling containers, and vehicles in residential driveways.

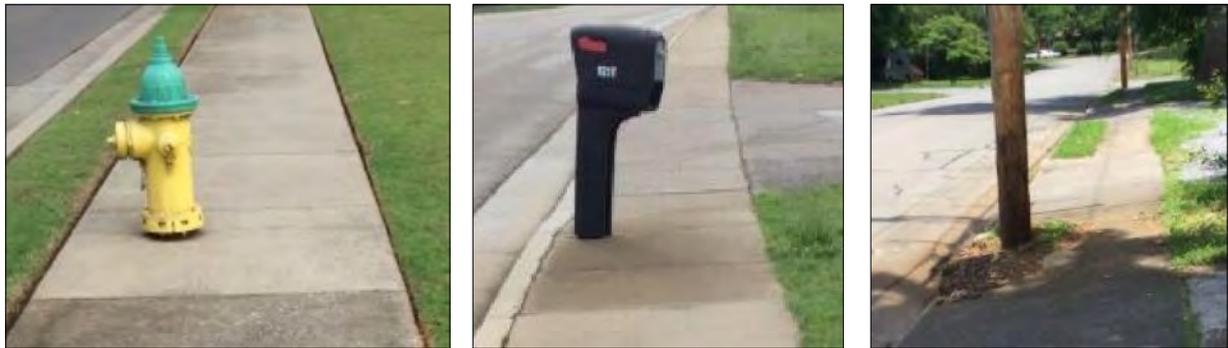
Examples of obstructions of the PAR that reduces the width to less than 48".

Fixed obstructions may be costly to address as they generally occur with utilities and may require relocation or purchase of right-of-way from adjacent landowners. For these items, a work-around solution is often preferred. These may include widening a small portion of sidewalk where possible or providing an equivalent alternate route. Providing a narrow area of tree lawn between the curb and sidewalk can assist by providing an area for items such as signs and mailboxes to be placed without obstructing the PAR and can also assist with resolving issues for temporary items like trash and recycling containers.

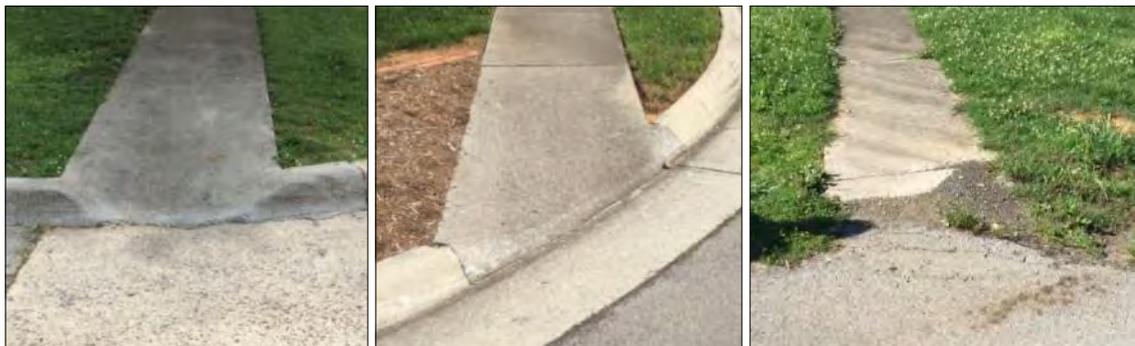
A vast majority of curb ramps evaluated were compliant for width. A relatively small number were less than the required 4' width and typically had other compliance issues that affected accessibility more than the width.

Examples of curb ramps that are less than the minimum 48" width required.

Ramp width is typically not restricted and attaining the minimum 48" should be accomplished without difficulty. In some cases there could be permanent obstructions but typically when curb ramps are too narrow it is a result of construction errors. If an unobstructed area is available within the ROW at a current non-compliant location for width, the ramp can be widened by replacement or addition of pavement. If ROW or an obstruction is a limiting factor, a different ramp configuration may alleviate the problem. If not, the ramp or obstruction may need to be relocated, or inquiries made about obtaining additional ROW.

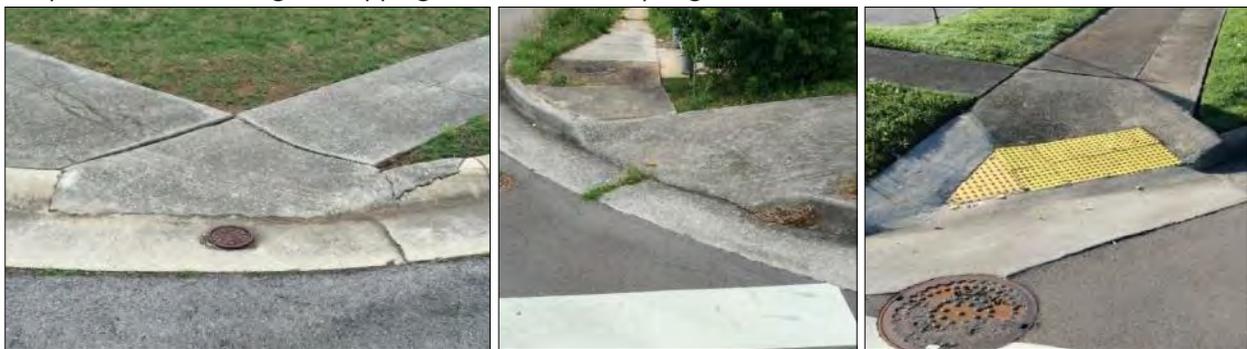
Within the City, there are a high number of primarily perpendicular curb ramps that do not provide compliant turning spaces. These locations typically are located where there is not adequate room to construct a perpendicular ramp and results in no turning space being provided. Wheelchairs attempting to use these ramps would be in danger of tipping over when attempting to turn.

Examples of perpendicular curb ramps that lack a compliant turning space.

As illustrated in the examples shown, curb ramps with non-compliant turning spaces often have other non-compliance issues. Parallel ramps with non-compliant turning spaces were often highly usable, though the lack of the level turning area can be problematic for wheelchair users during maneuvering to change directions.

Non-compliant turning spaces/landings are caused primarily by construction of the wrong kind of ramp in a space that is inadequate to provide the required slopes and dimensions. In most cases the only means to provide a compliant turning space/landing is to reconstruct the ramp and use a parallel configuration. In areas where there is adequate space that we simply not used in the original construction, reconstruction to the extent needed to provide compliant dimensions and slopes is needed.

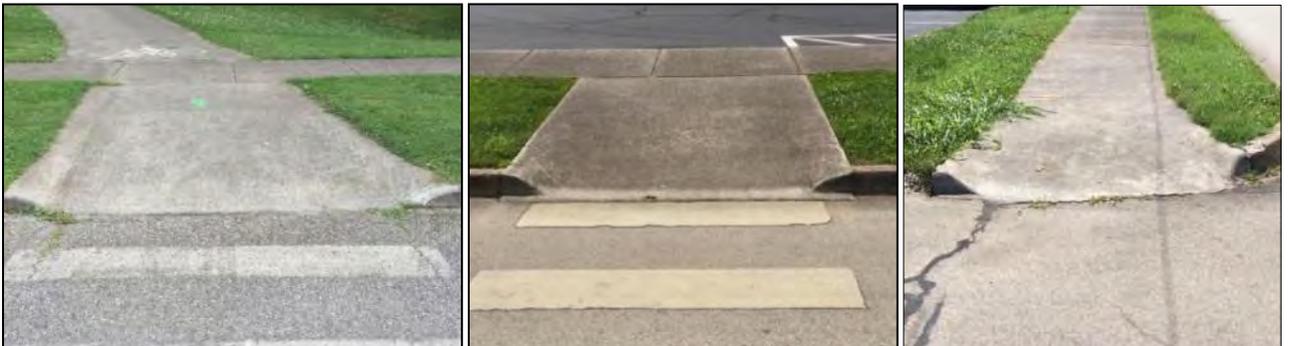
Example of curb ramps that do not require flares due to no PCA adjacent to the ramp being present.

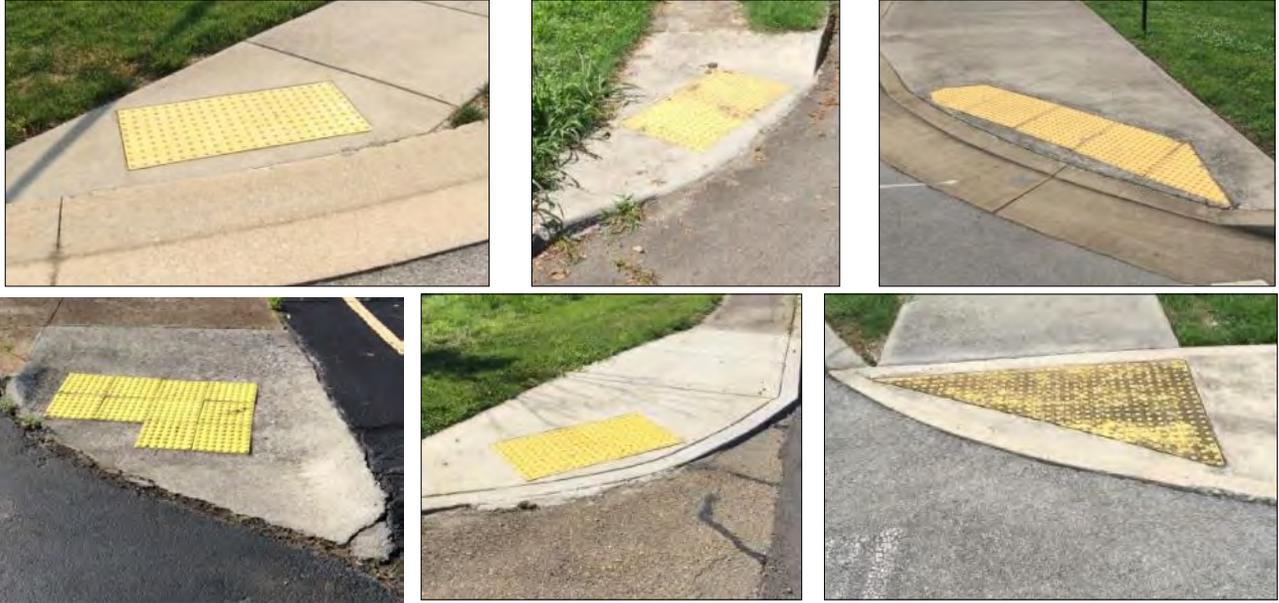
DWs that are oriented poorly and are not 24" depth in entire direction of pedestrian movement.

In many cases, curb ramps with non-compliant or missing DWs have other issues that cannot be easily addressed without reconstruction. Retrofit DW kits are available for use on ramps where all other criteria are compliant and should be considered for use in these locations. Some non-compliant locations with high pedestrian volumes or known blind pedestrian users should be considered for these retrofit kits until the ramp can be corrected entirely. For locations where the DW does not extend full width or required 24" depth, they can be removed and replaced along with any concrete damaged by the operation. For all future DW installations, steel, HDPE, or cast-iron products that provide greater durability for the truncated domes are recommended. Using these products in lieu of a brick or cast concrete panel may minimize plow damage and wear of truncated domes.

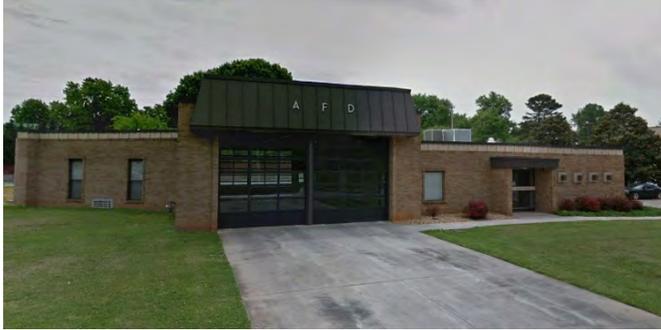
Fire Station 2

Item #	Description	Priority	Probable Cost
07-1	<i>Dayroom Drinking Fountain</i>		
	<i>Provide Paper Cup Dispenser</i>	Low	\$100
	Notes: 2 drinking fountains are required, only 1 is provided. Bubbler height of 33" is accessible to wheelchair user only but underclearance for knee space is only 26-3/4" (27" min. req'd.). Cup dispenser is temporary measure to provide access to wheelchair user until fountain can be replaced during future renovation. Water stream height only 3", review to increase to 4" min. Federal Guideline: 211, 602.7, 602.6

08b-1	<i>Door from Lobby to Firefighter Area</i>		
	<i>Provide Wall Signage</i>	Low	\$100
	Notes: No wall signage provided. Braille and raised text signage required on latch side of door. Federal Guideline: 407.4.3, 703.2-4		
	<i>Replace Door Hardware</i>	Low	\$220
	Notes: Knobs on door require grasping and twisting. Latch is currently jammed and closer disengaged so knobs do not restrict access. Federal Guideline: 404.2.7		
09	<i>Corridor</i>		
	<i>Provide Compliant Wall Signage</i>	Low	\$300
	Notes: Several rooms lack signage. Provide compliant signs on all permanent spaces. Federal Guideline: 216.8, 703		
15	<i>Men's Restroom</i>		
	<i>Provide Compliant Signage</i>	Medium	\$200
	Notes: No signage provided. Provide sign that includes tactile text, the ISA, gender pictogram, and Braille. Federal Guideline: 216.8, 703.3-4		
	<i>Adjust Door Closer</i>	Low	\$450
	Notes: Door closes too quickly and operating force is 8 lbs. (5 lb. Federal Guideline: 404.2.8, 404.2.9

<i>Relocate Clothing Hooks</i>	Low	\$50
	Notes: Clothing hooks on wall located at 71" (15"-48" req'd.). Federal Guideline: 308, 608.3		
	<i>Provide Compliant Urinal</i>	Low	\$920
	Notes: Urinal lip for both is 25" (17" max.) height from floor and projects only 13" (13-1/2" min.). Flush control is at 54" (48" max.). Provide 1 new compliant urinal. Federal Guideline: 605.2		
	<i>Modify Stall Door Hinges, Add & Replace Hardware</i>	Low	\$300
	Notes: Stall door swings into the stall. Handles not provided on stall door (req'd. on both sides). Federal Guideline: 213.3, 604.8, 404.2, 309.4		
	<i>Provide Wheelchair Accessible Toilet Stall</i>	Low	\$1,500
	Notes: Two stalls present, neither are accessible. Two stalls provided, total width 71" (wheelchair stall 60" min.). Requires additional investigation of options to modify restroom and provide all the required clearances. Cost assumes reconfiguration of partitions and elimination of 1 stall. Federal Guideline: 404, 604

Notes: Electrical switch is at 54-1/2" (over 48" max. ht.). Install occupancy sensor with timer and correct when altered. Federal Guideline: 205.1, 308.2-3		
	<i>Relocate Clothing Hooks</i>	Low	\$50
	Notes: Clothing hooks on wall located at 64" (15"-48" req'd.). Federal Guideline: 308, 608.3		
	<i>Remove/Reposition Protruding Objects or Provide Permanent Cane-Detectable Obstruction Below</i>	Low	\$200
	Notes: Wall-mounted shelf protrudes 12-3/4" at 70" (4" max. between 27" and 80"). Federal Guideline: 307.2		
35	<i>Kitchen</i>		
	<i>Replace Door Hardware</i>	Low	\$220
	Notes: Knobs on door require grasping and twisting. Federal Guideline: 404.2.7		
	<i>Provide Maneuvering Space on Pull Side of Door</i>	Low	N/A
	Notes: Door maneuvering space not provided parallel to doorway on pull side (9" provided, min. 18"), is blocked by refrigerator. Door typically remains open at all times. Federal Guideline: 404.2.3-4, 404.2.7, 404.2.10

<i>Reposition Sink and Provide Knee Space Below with Pipe Insulation</i>	Medium	\$1,250
	Notes: Sink rim is 36-1/4" high (34" max. req'd.). Reposition such that rim of sink does not exceed 34" max. Kitchen with oven/range is required to have knee space below the sink, replace existing cabinet. Federal Guideline: 606.2, 606.3

<i>Provide Accessible Range</i>	Low	\$800
	Notes: Controls for range are not on front panel, requires reach over potentially hot burners and are too high. Federal Guideline: 804.6.4, 309		
	<i>Provide New Microwave</i>	Low	\$200
	Notes: Operable parts of existing microwave are above 48" max. Least costly option is to purchase a 2nd unit and place on countertop within reach range. Federal Guideline: 308, 309		
	Facility Total:		\$11,345
General Notes:

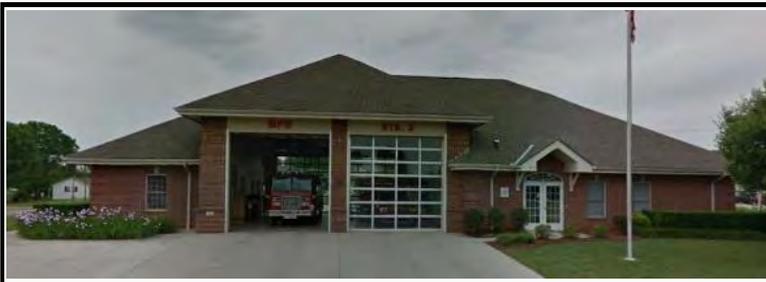
Fire Station 3

Item #	Description	Priority	Probable Cost
	Exterior Entrances		
08a-1	<i>Main Entrance Door</i>		
	<i>Replace Door Hardware</i>	Low	\$220
	Notes: Lock on door require grasping and twisting. Federal Guideline: 404.2.7		
	<i>Provide Means of Egress Signage</i>	High	\$100
	Notes: Visual only provided. Tactile required. Federal Guideline: 216.4, 703		
	<i>Replace Threshold</i>	Medium	\$250
	Notes: Threshold is 1" high (3/4" max. for existing, new 1/2" max. beveled). Federal Guideline: 404.2.5		
	<i>Provide Kick Plate on Push Side of Door</i>	Medium	\$110
	Notes: Only 8-1/2" from bottom of the door to glass (10" min. smooth req'd.). Federal Guideline: 404.2.10		
	<i>Provide Compliant Signage at Call Buttons</i>	Low	\$100
	Notes: No signage provided at call button. Provide signage at call button that provides both visual and tactile letters and Braille. Federal Guideline: 703		
	<i>Provide Maneuvering Space on Push Side of Door</i>	Low	TBD

<i>Provide Compliant Benches in Changing Area</i>	Low	\$600
	Notes: There are no benches in the changing room. Minimum of 1 that complies with 1004 is required. Federal Guideline: 803.4, 903		
35-1	<i>Kitchen</i>		
	<i>Reposition Sink and Provide Knee Space Below</i>	Low	\$750
	Notes: Sink rim is 37-1/2" high (34" max. req'd). Reposition such that rim of sink does not exceed 34" max. Kitchen with oven/range is required to have knee space below the sink, replace cabinet. Federal Guideline: 606.2, 606.3		
	<i>Provide Accessible Storage</i>	Low	\$600
	Notes: 50% of total amount of storage must be within 48" max. ht. reach range. Federal Guideline: 225, 305, 811.2		
	<i>Provide Accessible Range</i>	Low	\$800
	Notes: Controls for range are not on front panel, requires reach over potentially hot burners. Federal Guideline: 804.6.4		
	<i>Provide New Microwave</i>	Low	\$200
	Notes: Operable parts of existing microwave are above 48" max. Least costly option is to purchase a 2nd unit and place on countertop within reach range. Federal Guideline: 308, 309

Item #	Description	Priority	Probable Cost
	<i>Remove/Reposition Protruding Objects or Provide Permanent Cane-Detectable Obstruction Below</i>	Low	\$200
	Notes: Wall-mounted telephone protrudes 4-1/2" at 52" (4" max. between 27" and 80"). Federal Guideline: 307.2		
	Facility Total:		\$9,945
General Notes:

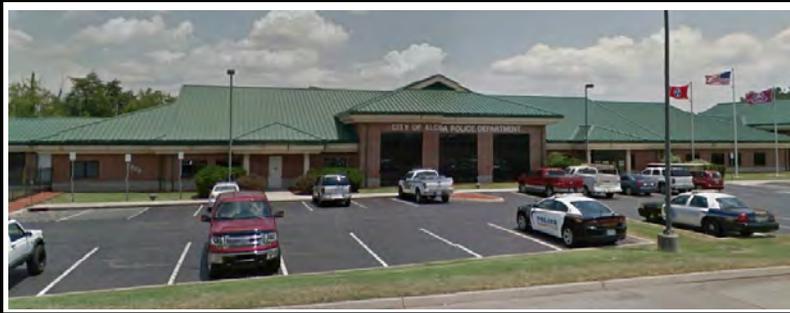
Police

Item #	Description	Priority	Probable Cost
02	Curb Ramp		
	<i>Replace Curb Ramp</i>	Medium	\$3,000
	Notes: Curb ramp does not provide level turning space, 2% max. req'd., existing is over 6%. Not located closest to accessible entrance. Construct a new ramp that has direct access to shared access aisle for van space with compliant width and aisle in line with entrance. Cost includes new ramp and removal of existing with new walk. Federal Guideline: 406.4		
Interior

<i>Provide Kick Plate on Push Side of Door</i>	Medium	N/A
	Notes: Only 8" from bottom of the door to glass (10" min. smooth req'd.). Optional item as doors have power openers. Federal Guideline: 404.2.10		
	<i>Provide Compliant Signage at Power Door Opener</i>	Low	\$100
	Notes: Replace outside button, is extremely faded and not legible. Federal Guideline: 703		
	<i>Provide Maneuvering Space on Push Side of Door</i>	Low	TBD
	Notes: Door maneuvering space not provided parallel to doorway on push side (2" provided, min. 12"). Explore options. Federal Guideline: 404.2.3-4, 404.2.7, 404.2.10		
	<i>Provide Compliant Signage at Telephone in Vestibule</i>	Low	\$100
	Notes: No tactile signage provided. Provide signage at telephone that provides both visual and tactile letters and Braille. Federal Guideline: 703		
	<i>Provide Compliant Two-Way Communication</i>	Medium	\$400
	Notes: Two-way communication systems are required to provide both audible and visual indicators of communications. Only audible currently provided via telephone. Federal Guideline: 708

Notes: Stall door is located 5-1/2" from wall (within 4" from partition or wall req'd.). Federal Guideline: 604.8.1.2		
	<i>Reposition Toilet</i>	Medium	\$765
	Notes: Centerline of toilet located at 20-1/2" from side wall (16"-18" req'd.). Federal Guideline: 604.2		
	<i>Replace Flush Controls</i>	Medium	\$400
	Notes: Flush controls are not located on wide side of toilet. Replace with auto flush sensor. Federal Guideline: 604.6

<i>Reposition Toilet</i>	Medium	\$765
	Notes: Centerline of toilet located at 19-1/2" from side wall (16"-18" req'd.). Federal Guideline: 604.2		
	<i>Replace Flush Controls</i>	Medium	\$400
	Notes: Flush controls are not located on wide side of toilet. Replace with auto flush sensor. Federal Guideline: 604.6

<i>Provide Access to Witness Stand</i>	High	\$2,000
	Notes: Access with a 7-1/2" step up from main level. Space is only 40" x 40" (required min. 48", 60" recommended in all directions). Reconfigure to remove step and provide larger space for wheelchair user. Federal Guideline: 305, 808		
	<i>Provide Accessible Work Surface for Court Reporter</i>	Medium	\$500
	Notes: Knee space is only 25-1/4" (27" ht. min. req'd.) due to keyboard tray. Cost assumes some casework may be needed. Federal Guideline: 904.4.1, 904.4.2

Notes: Braille on wall sign outside the room is separated from adjacent tactile letters by only 1/4" (3/8" min. req'd.). Federal Guideline: 703.2-3		
35-1	<i>Break Room Kitchen</i>		
	<i>Reposition Sink and Provide Knee Space Below with Pipe Insulation</i>	Medium	\$1,250
	Notes: Sink rim is 36-1/4" high (34" max. req'd.). Reposition such that rim of sink does not exceed 34" max. Kitchen with oven/range is required to have knee space below the sink, replace existing cabinet. Federal Guideline: 606.2, 606.3		
	<i>Lower Light Switch or Provide Occupancy Sensor</i>	Low	N/A
	Notes: Electrical switches at 50" (over 48" max. ht.) but up to 54" allowed by 1991 ADAAG. Correct when altered. Federal Guideline: 205.1, 308		
	<i>Provide Accessible Storage</i>	Low	TBD
	Notes: 50% of total storage must be within 48" max. ht. reach range. Federal Guideline: 225, 305, 811.2		
	<i>Relocate Items or Provide Additional</i>	Low	\$200

Notes: Operable parts of existing microwave are above 48" max. Least costly option is to provide additional microwave within reach range. Federal Guideline: 307.2		
	<i>Provide Clear Space at Refrigerator</i>	Low	\$200
	Notes: Refrigerator door opens away from adjacent wall, would be difficult for wheelchair user to operate. Consider reversing swing on doors. Federal Guideline: 804.6.6		
	<i>Provide Accessible Range</i>	Low	\$800
	Notes: Controls for range are not on front panel, requires reach over potentially hot burners. Federal Guideline: 804.6.4		
	<i>Provide Visual Fire Alarms</i>	Medium	\$400
	Notes: Visual fire alarms must be located in common use and general circulation areas. None in this space. Federal Guideline: 215.1, 702.1, NFPA 72

Item #	Description	Priority	Probable Cost
	120-125 Intake and Holding Area		
08b-5	120 Entry Door		
	Provide Compliant Wall Signage	Low	\$200
	Notes: Braille on wall sign outside the room is separated from adjacent tactile letters by only 1/4" (3/8" min. req'd.) and bottom of highest tactile characters at 62-1/2" (60" max.). Provide new sign at compliant height. Federal Guideline: 407.4.3, 703		
16-1	Holding Area Unisex Restroom		
	Replace and Relocate Signage	Low	\$50
	Notes: Current sign is on the door, which swings out (allowed only on in-swinging door with closer) and highest tactile letters are above 60" max. Braille is located 1/4" from adjacent tactile letters (3/8" min. req'd.). Provide new sign on wall adjacent to latch side at compliant height. Federal Guideline: 216.8, 703.3.2, 703.6		
	Reposition Sink	Low	\$750
	Notes: Sink rim is at 34-1/4" high (34" max.). Reposition such that rim of sink does not exceed 34" max. Federal Guideline: 606.3

Reposition Toilet	Low	\$765
	Notes: Centerline of toilet located at 19-1/2" from side wall (16"-18" req'd.). Federal Guideline: 604.2		
	Provide Clear Space at Toilet	Medium	included above
	Notes: Existing clear space from near wall of toilet to sink is 57" (60" min. req'd.). Explore options, which may include moving sink to provide clear area, cost included in "Reposition Sink" item above. Federal Guideline: 604.3.1		
	Provide Toilet Paper Dispenser	Low	\$100
	Notes: No dispenser provided, toilet paper currently placed loosely on grab bar. Provide dispenser mounted 7"-9" in front of toilet to centerline. Federal Guideline: 604.7		
	Provide Compliant Grab Bars	Low	\$600
	Grab bar surface at 36-1/2" (33-36" req'd.) and space between bars and wall exceeds 1-1/2" max. Reposition to 36" max. height and ensure surface mount provides max. 1-1/2" space. Federal Guideline: 609.3, 609.4		
16-2	Staff Unisex Restroom

NOTE: used by staff only, provide directional signage for locker rooms, consider this restroom as non-accessible and provide sign without ISA. This restroom is too small to make comply with standards without enlarging the room by moving walls. Address items noted below regardless.		
	Provide Compliant Signage, Including Directional Sign	Low	\$200
	Notes: No sign provided, provide sign on wall adjacent to latch side at compliant height and directional sign pointing towards locker rooms. Federal Guideline: 216.8, 703.3.2, 703.6		
	Provide Visual Fire Alarms	Medium	\$400
	Notes: Visual fire alarms must be located in common use and general circulation areas. None in this space. Federal Guideline: 215.1, 702.1, NFPA 72

Notes: Stall door is located 5-1/2" from wall (within 4" from partition or wall req'd.). Federal Guideline: 604.8.1.2		
	<i>Reposition Toilet Paper Dispenser</i>	Low	\$50
	Notes: Dispenser mounted 3-1/2" in front of toilet (7"-9" to centerline req'd.). Federal Guideline: 604.7		
	<i>Reposition Grab Bars</i>	Low	\$600
	Grab bar surface at 37" (33-36" req'd.). Reposition to 36" max. Federal Guideline: 609.4		
	<i>Relocate Coat Hook</i>	Low	\$50
	Notes: Coat hook on inside of stall door located at 53-1/2" ht. (15"-48" Federal Guideline: 308, 603.4		
17b-2	<i>Women's Locker Room Shower</i>		
	<i>Relocate Clothing Hooks</i>	Low	\$100
	Notes: All hooks in shower area are located at 55-1/2" ht. (15"-48" req'd). Federal Guideline: 308, 603.4		
	<i>Provide Compliant Shower Head</i>	Low	\$100
	Notes: Existing shower head not easily removed, consider different unit. Federal Guideline: 608.6		
	<i>Provide Compliant Transfer Shower</i>	Low	\$400

Notes: Existing shower depth is 38" and width 35-1/4" (36" absolute req'd. for both). Used only by officers. Federal Guideline: 608.2.1		
19-2	<i>Women's Locker Room</i>		
	<i>Provide Compliant Benches in Changing Area</i>	Medium	\$600
	Notes: Existing benches do not meet ADA requirements, are not fixed as required and are only 9-1/2" wide (20-24" req'd.). Accessible benches required to be 42" long and 20-24" wide with back support and adjacent clear area for wheelchair. Minimum of 1 that complies with 1004 is required. Federal Guideline: 803.4, 903

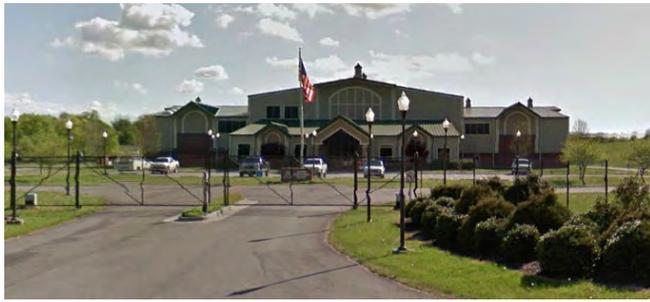
Water Filtration Plant

<i>Adjust Door Closer</i>	Low	\$450
	Notes: Opening force is 6 lbs. (5 lbs. max.). Cost is for new closer. Federal Guideline: 404.2.9		
35	<i>Break Room Kitchen</i>		
	<i>Reposition Sink and Provide Knee Space Below with Pipe Insulation</i>	Medium	\$1,250
	Notes: Sink rim is 36-1/2" high (34" max. req'd.). Reposition such that rim of sink does not exceed 34" max. Kitchen with oven/range is required to have knee space below the sink, replace existing cabinet. Federal Guideline: 606.2, 606.3		
	<i>Provide Accessible Storage</i>	Low	TBD
	Notes: 50% of total storage must be within 48" max. ht. reach range. Federal Guideline: 225, 305, 811.2		
	<i>Relocate Items or Provide Additional</i>	Low	\$200
	Notes: Operable parts of existing microwave are above 48" max. Least costly option is to provide additional microwave within reach range. Federal Guideline: 307.2		
	<i>Provide Accessible Range</i>	Low	\$800

Notes: Controls for range are not on front panel, requires reach over potentially hot burners. Federal Guideline: 804.6.4

<i>Adjust Door Closer</i>	Low	\$450
	Notes: Operating force is 7 lbs. (5 lb. max.). Cost is for new closer. Federal Guideline: 404.2.9		
	<i>Reposition Mirror</i>	Low	\$50
	Notes: Bottom edge of reflecting surface over sink is at 41" ht. (40" max.). Federal Guideline: 603.3		
	<i>Provide Access to Accessible Urinal</i>	Low	\$100
	Notes: Accessible urinal access is only 29-1/2" wide (30" req'd.). Move partition wall to provide clear width required. Federal Guideline: 605.3		
	<i>Modify Wheelchair Stall Door</i>	Medium	\$100
	Notes: Spring hinges need to be replaced, door is not self-closing as required. Federal Guideline: 213.3, 604.8, 404.2		
	<i>Replace or Reposition Wheelchair Stall Partition</i>	Low	\$600
	Notes: Stall door is located 5-1/2" from wall (within 4" from partition or wall req'd.). Federal Guideline: 604.8.1.2		
	<i>Reposition Toilet</i>	Low	\$765
	Notes: Centerline of toilet located at 18-1/4" from side wall (16"-18" req'd.). Federal Guideline: 604.2

<i>Reposition Mirror</i>	Low	\$50
	Notes: Bottom edge of reflecting surface over sink is at 40-1/4" ht. (40" max.). Federal Guideline: 603.3		
	<i>Lower Light Switch or Provide Occupancy Sensor</i>	Low	N/A
	Notes: Electrical switches at 50-1/2" (over 48" max ht.) but up to 54" allowed by 1991 ADAAG. Correct when altered. Federal Guideline: 205.1, 308		
	<i>Modify Wheelchair Stall Door</i>	Medium	\$100
	Notes: Spring hinges need to be replaced, door is not self-closing as required. Federal Guideline: 213.3, 604.8, 404.2		
	<i>Replace or Reposition Wheelchair Stall Partition</i>	Low	\$600
	Notes: Stall door is located 5-1/4" from wall (within 4" from partition or wall req'd.). Federal Guideline: 604.8.1.2		
	<i>Reposition Toilet</i>	Low	\$765
	Notes: Centerline of toilet located at 19" from side wall (16"-18" req'd.). Federal Guideline: 604.2		
	<i>Reposition Toilet Paper Dispenser</i>	Low	\$50
	Notes: Dispenser mounted 5" in front of toilet (7"-9" to centerline req'd.). Federal Guideline: 604.7

<i>Reposition Grab Bars</i>	Low	\$600
	Side grab bar only extends 48-1/2" from rear wall (54" min. req'd.). Rear grab bar is centered 11-1/2"/24-1/2" (12"/24" req'd.). Federal Guideline: 609.4, 604.5		
	<i>Relocate Coat Hook</i>	Low	\$50
	Notes: Coat hook on inside of stall door located at 65" (18- 48" req'd.). Federal Guideline: 308, 603.4		
17b-2	<i>Women's Locker Room Shower</i>		
	<i>NOTE: Existing shower stall is not compliant as noted below (measurements are assumed due to items stored within shower) but is not used. Shower is currently used for storage of various items and access is restricted by chair full of additional items.</i>		
	<i>Provide Compliant Fixed Shower Head</i>	Low	\$100
	Notes: Fixed shower head at 75" (48" max. req'd.). Federal Guideline: 608.6		
	<i>Provide Compliant Transfer Shower</i>	Medium	\$2,500
	Notes: Existing shower has 5/8" threshold (1/2" max.), 46-1/2" width (36" absolute req'd.), depth is 35-1/2" (36" absolute req'd.), and has non-compliant grab bars. Seat is permanent but not compliant. Federal Guideline: 608.2.1, 608.3, 608.7, 609.4

19-2	<i>Women's Locker Room</i>		
	<i>Provide Compliant Benches in Changing Area</i>	Medium	\$600
	Notes: Existing benches do no meet ADA requirements, are only 9-1/2" wide (20-24" req'd.), and are 4" from wal (2-1/2" max.). Accessible benches required to be 42" long and 20-24" wide with back support and adjacent clear area for wheelchair. Minimum of 1 that complies with 1004 is required. Federal Guideline: 903.3		
	<i>Provide Accessible Lockers</i>	Medium	\$800
	Notes: 6 lockers present, 5% (1) is required to be accessible. Existing lockers have little usable space within 48" reach range, with shelf and hooks within above 48". Provide minimum of 1 accessible lockers. Federal Guideline: 225.2.1, 308, 403.5.1, 811.3		
	Facility Total:		\$33,215
General Notes:

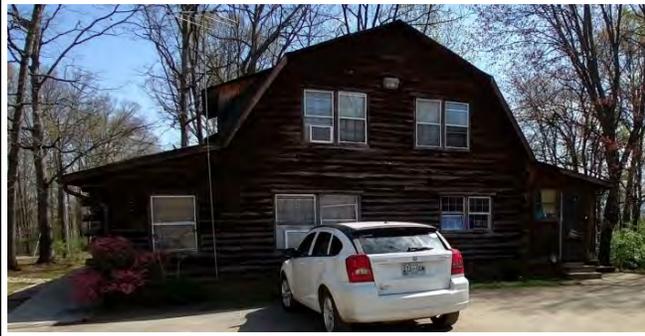
Landfill

Item #	Description	Priority	Probable Cost
08a-1	Front Entrance		
	<i>Provide Means of Egress Signage</i>	High	\$300
	Notes: None provided at public entrance or two other exits. Federal Guideline: 216.4, 703		
	<i>Provide Compliant Threshold</i>	Medium	\$200
	Notes: Existing threshold is 1-1/2" (3/4" max. beveled allowed for existing). Federal Guideline: 404.2.10		
	<i>Replace Door Hardware</i>	Low	\$220
	Notes: Knobs on door require grasping and twisting. Federal Guideline: 404.2.7		
	<i>Provide Kick Plate on Push Side of Door</i>	Medium	\$110
	Notes: Only 8-1/2" from bottom of the door to woodwork (10" min. smooth req'd.). Federal Guideline: 404.2.10		
	<i>Provide Maneuvering Space on Pull Side of Door</i>	Low	TBD
	Notes: Door maneuvering space not provided parallel to doorway on pull side (48" required depth for parallel approach blocked by stairs). Explore options. Federal Guideline: 404.2.4.1

<i>Provide Compliant Wall Signage</i>	Low	\$200
	Notes: No signage provided. Braille and raised text signage required. Federal Guideline: 407.4.3, 703.2-4		
	<i>Replace Door and Hardware</i>	Low	TBD
	Notes: Clear width entry of door is only 26" (32" min. req'd.). Knob hardware on door requires grasping and twisting. Federal Guideline: 404.2.3, 404.2.7		
	<i>Provide Turning Space Within Room</i>	Low	TBD
	Notes: Minimum 60" diameter turning space for wheelchair required and not available. Federal Guideline: 304.3, 306.2, 606.2		
	<i>Provide Compliant Sink with Knee Space Below</i>	Medium	\$1,250
	Notes: Existing sink contained with cabinet that provides no knee or toe space for wheelchair. Inadequate clear space. Federal Guideline: 306.3, 606.2, 606.3		
	<i>Reposition Mirror</i>	Low	\$50
	Notes: Bottom edge of reflecting surface over sink is at 49-1/2" ht. (40" max.). Federal Guideline: 603.3		
	<i>Reposition Towel Dispenser</i>	Low	\$50

<i>Provide Compliant Benches in Changing Area</i>	Medium	\$600
	Notes: There are no benches in the changing room. Minimum of 1 that complies with 1004 is required. Federal Guideline: 803.4, 903		
	<i>Provide Accessible Shower</i>	Low	TBD
	Notes: Existing shower lacks accessible features. Shower grab bars, seat, proper dimensions and clear spaces, removable shower head, and other accessible features are lacking. Federal Guideline: 607, 608, 609		
35	<i>Kitchen</i>		
	<i>Reposition Sink and Provide Knee Space Below with Pipe Insulation</i>	Medium	\$1,250
	Notes: Sink rim is 35-1/2" high (34" max. req'd.). Reposition such that rim of sink does not exceed 34" max. Kitchen with oven/range is required to have knee space below the sink, replace existing cabinet. Federal Guideline: 606.2, 606.3		
	<i>Provide Accessible Storage</i>	Low	TBD
	Notes: 50% of total storage must be within 48" max. ht. reach range. Federal Guideline: 225, 305, 811.2

Item #	Description	Priority	Probable Cost
	<i>Relocate Items</i>	Low	\$200
	Notes: Operable parts of telephone and fire extinguisher are above 48" max. Federal Guideline: 307.2		
	<i>Protect Protruding Objects</i>	Low	\$50
	Notes: Time clock and mailboxes protrude 10" at 39". Provide permanent cane detectable element below or move shelving out of accessible route. Federal Guideline: 307.2		
	<i>Provide Accessible Range</i>	Low	\$800
	Notes: Controls for range are not on front panel, requires reach over potentially hot burners. Federal Guideline: 804.6.4		
	<i>Provide Compliant Drinking Fountain</i>	Low	N/A
	Notes: Existing drinking fountain not operational. If it is repaired it is a single unit that will not provide access to wheelchair user. Federal Guideline: 211, 602.7		
	Facility Total:		\$9,580
General Notes:

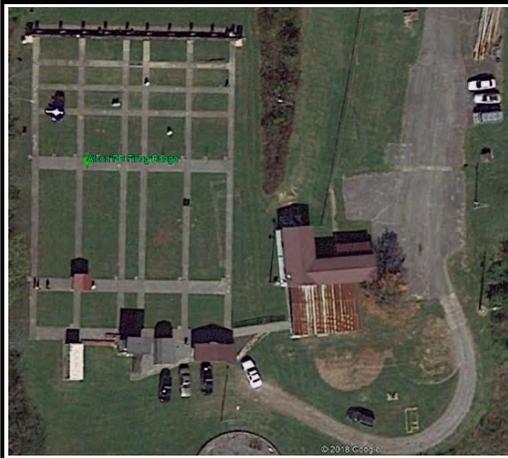
City Gun Range

Item #	Description	Priority	Probable Cost
	Parking Lot and Accessible Routes		
01a	<i>Parking Lot</i>		
	<i>No spaces are marked, room for less than 25. No accessible spaces provided, requires 1 van space.</i>		
	<i>Provide Accessible Parking Space</i>	N/A	N/A
	Notes: Provide marked van-accessible space with access aisle and sign with ISA. Parking lot slopes and condition vary greatly. Federal Guideline: 208.2, 208.3		
04	<i>Accessible Routes</i>		
04-1	<i>Accessible Routes</i>		
	<i>Provide an accessible route.</i>	N/A	N/A
	Notes: There is no compliant accessible route from the parking into the covered porch and into the building. Route includes level changes, non-compliant turf surface, etc. Federal Guideline: 206.2.1, 403.5.1, 303, 403.4

Notes: Door has knob hardware. Federal Guideline: 216.4, 703		
	Rear Room Past Kitchen		
07	<i>Main Hall Drinking Fountain</i>		
	<i>Replace Non-Compliant Drinking Fountains</i>	N/A	N/A
	Notes: "Hi-lo" fountain is not provided. Bubbler height at 39" provides accessibility only to standing user. Water stream less than 1" (4" min. req'd.). Federal Guideline: 211, 602, 305.7.1, 307, 309		
	<i>Provide Compliant Sink</i>	N/A	N/A
	Notes: Hand sink has no insulation on piping below. Federal Guideline: 606.2, 606.3		
16	Unisex Restroom		
	<i>Provide Compliant Restroom</i>	N/A	N/A
	Notes: Restroom has no signage, non-compliant knob hardware, doorway entry width less than 32", inadequate room for turning space and clear spaces, mirror at 47" (40" max.), etc. Federal Guideline: 216.8, 703.3-4

Item #	Description	Priority	Probable Cost
35	Kitchen Area		
	<i>Reposition Sink and Provide Compliant Hardware</i>	N/A	N/A
	Notes: Sink rim is 36-1/2" high (34" max. req'd.). Reposition such that rim of sink does not exceed 34" max. Faucet hardware requires grasping and twisting. Federal Guideline: 606.2, 606.3		
	<i>Reposition AED</i>	N/A	N/A
	Notes: Operable part at 60" above 48" max. Federal Guideline: 307.2		
	Facility Total:		\$0

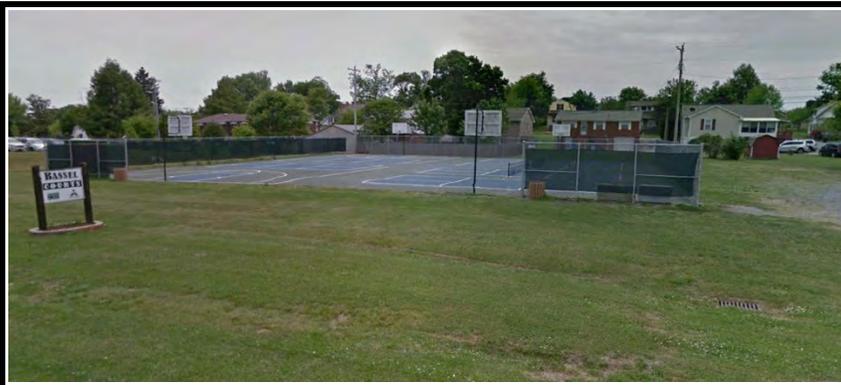
Bassell Courts Data collected April 2018

Item #	Description	Priority	Probable Cost
01	Parking		
	<i>Parking spaces are not marked but less than 25 available, including 0 designated as accessible. 1 van space required.</i>		
	<i>Provide Accessible Parking Space</i>	High	\$2,000
	Notes: Space is not marked and there is no signage. Provide 1 van stall (8' min. space/8' min. aisle) with aisle located at sidewalk to entrance. Provide signage with van-accessible tag. Parking lot surfacing is not a compliant surface (loose gravel). Provide compliant surface for space and access aisle. Federal Guideline: 208.2, 208.2.4, 302.1, 502.6		
04	Accessible Routes		
	<i>Provide Compliant Accessible Routes</i>	High	\$2,500
	Notes: There is no compliant surface connecting parking to the sports courts. Provide a compliant accessible route that connects to the parking access aisle and courts. Federal Guideline: 302.1		
	Park Amenities		
22	Site Furniture		
	<i>Provide Accessible Picnic Tables to Accommodate 4 Wheelchair Spaces</i>	Medium	\$4,800

Notes: Total of 11, 8' picnic tables provided. 1 wheelchair space required for each 24 linear feet of usable table surface perimeter (each table has 22 linear feet x 11 = 11 spaces required. Surface of tables in pavilion are at 27-1/4" (28-34" req'd.), and underclearance for wheelchair knee space at pavilion is 26" (27" min.) and depth is 10" (11" min. req'd.). Table in lawn do not comply either. Provide 6 new tables that meet requirements and provide 11 wheelchair spaces. Ensure tables are located to provide clear space for wheelchair approach. Federal Guideline: 206.2.2, 403, 1011.4.2, 902.3, 306.3.1-3		
	Facility Total:		\$9,300

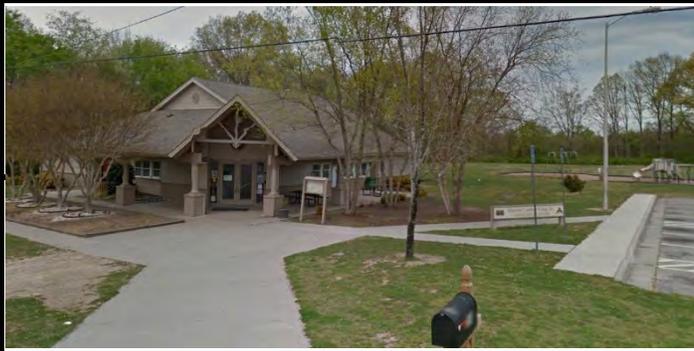
Martin Luther King Community Center

Community Room		
07	<i>Drinking Fountain</i>		
	<i>Provide Paper Cup Dispenser</i>	Low	\$100
	Notes: 2 drinking fountains are required, only 1 is provided. Bubbler height is accessible to wheelchair user only. Cup dispenser is temporary measure to provide access to wheelchair user until fountain can be replaced during future renovation. Water stream height only 2", review to increase to 4" min. Federal Guideline: 211, 602.7, 602.6		
	<i>Provide Compliant Alcove</i>	Low	N/A
	Notes: Drinking fountain is required to be in an alcove and not protrude over 4" into hallway. Current fountain not high enough to be considered a protruding object. Federal Guideline: 305.7.1, 602.2, 307		
08b -2	<i>Typical Interior Door</i>		
	<i>Replace Door Hardware</i>	Low	\$1,320
	Notes: Lock requires grasping and twisting on several doors. Federal Guideline: 404.2.7		
	<i>Provide Wall Signage</i>	Low	\$700
	Notes: No wall signage provided on exempted space doors. Braille and raised text signage required on latch side of door. Federal Guideline: 407.4.3, 703.2-4

<i>Modify Stall Door Hinges, Add & Replace Hardware</i>	Low	\$300
	Notes: The latch plate is gone so the stall door swings both ways and cannot lock. Handles not provided on stall door (req'd. on both sides). Federal Guideline: 213.3, 604.8, 404.2, 309.4		
	<i>Modify Toilet Seat</i>	Low	\$75
	Notes: Toilet seat height is at 19-1/4" high (17" min. -19" max. req'd.). Federal Guideline: 604.4		
	<i>Reposition Toilet Paper Dispenser</i>	Low	\$50
	Notes: Toilet paper dispenser is located within 12" clear space req'd. above side grab bar. Relocate to min. 1-1/2" below grab bar. Federal Guideline: 609.3		
15-2	Women's Restroom		
	<i>Relocate Signage</i>	Medium	\$50
	Notes: Sign is located on a door that has a hold-open device, which is not allowed. Sign is also located with the bottom of the lowest tactile letters at 36" (48" min.). Move sign to the wall adjacent to the latch and ensure that the bottom of the letters "WOMEN" is between 48" and 60". Federal Guideline: 216.8, 703

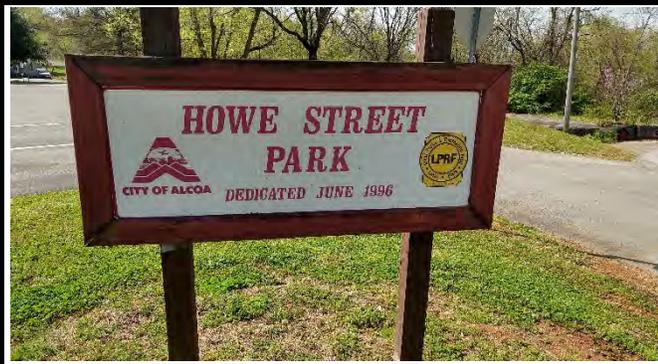
Howe Street Park

25	Play Equipment Area		
	<i>Provide Accessible Route to and within Play Area</i>	Medium	\$3,000
	Notes: Must cross turf area to access perimeter of play area, surfacing within play area is compacted wood fibers which provide varying degrees of compliance. Several areas require maintenance. Provide firm, stable, slip resistant surface meeting CPSC requirements for fall protection within play area. Wood mulch surface is provided. Provide compliant surface from sidewalks to perimeter of play area. Cost shown includes sidewalk connection and maintenance of select areas, not surfacing of entire play area. Federal Guideline: 206.2.2, 403.3		
	<i>Replace Transfer Steps at Play Component</i>	Medium	\$1,500
	Notes: Transfer step at turn is triangular and does not meet 14" min. depth x 24" min. width and provides no railing. Transfer step from triangular landing to upper step is 13" high (8" max.). Federal Guideline: 1008.3.2

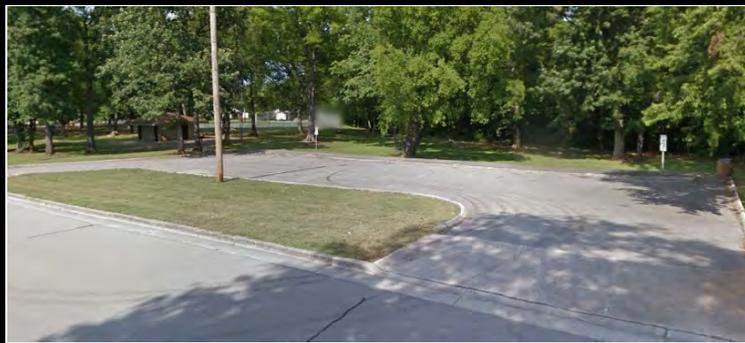
Rock Garden Park

22	Site Furniture		
	<i>Provide Accessible Picnic Tables to Accommodate Wheelchairs</i>	Medium	\$12,000
	Notes: 6 picnic tables provided but only 1 is located on an accessible route and only 1 wheelchair space is provided (3 req'd.). Provide 2 additional wheelchair spaces at picnic tables that are on an accessible route and provide 36" wide clear space around all usable sides of all tables. Cost includes enlarging existing concrete pad for table on accessible route, constructing new pad adjacent to accessible route near bench, enlarging 1 additional pads with accessible route, and replacing 2 existing picnic tables with 8' tables that provide wheelchair access at the end. Federal Guideline: 902, 306.3.1		
	<i>Provide Accessible Route and Clear Space at Grill</i>	Low	\$150
	Notes: Grill is located in lawn and does not provide a minimum clear, level space 48"x 48" on all usable sides of the grill. Relocate or provide new grill to area adjacent to one of reconfigured picnic tables described above. Federal Guideline: 1011.2.1

25	Play Equipment Area		
	<i>Provide Accessible Route to and within Play Area</i>	Medium	\$1,000
	Notes: Elevation change from accessible route into the play area. Surfacing within play area is compacted wood fibers which provide varying degrees of compliance. Several areas require maintenance. Provide firm, stable, slip resistant surface meeting CPSC requirements for fall protection within play area. Wood mulch surface is provided. Provide compliant surface from sidewalks to perimeter of play area. Cost shown includes maintenance of select areas, not surfacing of entire play area. Federal Guideline: 206.2.2, 403.3		
	Facility Total:		\$35,000
General Notes:

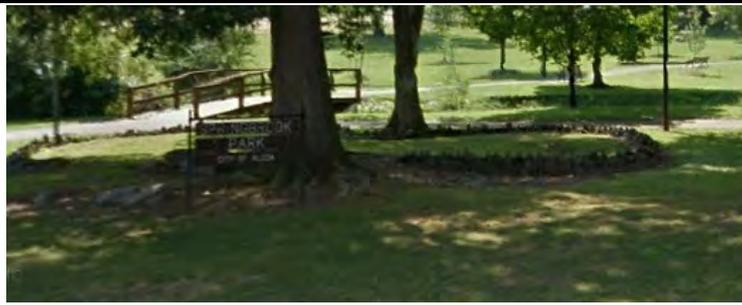
Springbrook Park

25-2	<i>Northwest Play Area</i>		
	<i>Provide Accessible Route to and within Play Area</i>	Medium	\$5,000
	Notes: Must cross turf area to access perimeter of play area. Wood mulch surface is provided within play area, several areas require maintenance and may not be suitable surface to provide access to all play elements. Provide firm, stable, slip resistant surface meeting CPSC requirements for fall protection within play area. Provide compliant surface from sidewalks to perimeter of play area. Cost shown includes sidewalk connection and maintenance of select areas, not surfacing of entire play area. Federal Guideline: 206.2.2, 302, 403.3, 1008.2.6		
	<i>Provide Compliant Transfer Platform and Steps</i>	Low	\$600
	Notes: Transfer step is triangular and not the full 10"x24" dimension req'd. Federal Guideline: 1008.3.2		
25-3	<i>Workout Area</i>		
	<i>NOTE: Outdoor workout areas are not specifically covered in the ADA Standards. Evaluation was performed with focus on accessible routes and clear spaces to allow access to all equipment by person in a wheelchair. Not considered to be a play area, therefore CPSC fall protection does not apply though could still be a consideration for surfacing.</i>

<i>Provide Accessible Route to and within Workout Area</i>	Medium	\$3,500
	Notes: Wood mulch surface is provided within area, several areas require maintenance and may not be suitable surface to provide access to all workout elements. Large elevation change from basketball court concrete to mulch. Provide firm, stable, slip resistant surface meeting CPSC requirements for fall protection within play area. Cost shown includes sidewalk connection from basketball courts into the workout area to eliminate elevation change and maintenance of select areas needed to provide a route to all equipment, not surfacing of entire area. Federal Guideline: 206.2.2, 302, 403.3, 1008.2.6		
	Facility Total:		\$57,550
General Notes:

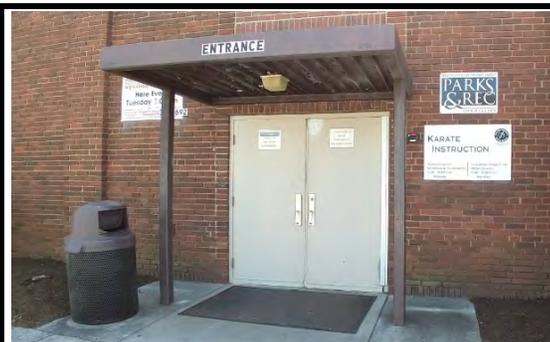
Springbrook Recreation Center

<i>Replace Faucets</i>	Medium	\$200
	Notes: Faucets provided require grasping and twisting to operate. Provide new compliant controls. Federal Guideline: 309, 606.4		
	<i>Relocate Light Switch or Provide Occupancy Sensor</i>	High	\$250
	Notes: Electrical switches at 49-1/2" (over 48" max ht.). Control is located outside of restroom, which would allow non-user of restroom to operate. Relocate light controls into the restroom or provide occupancy sensor so user has full control of lighting within. Federal Guideline: 205.1, 308		
	<i>Construct New Wall and Relocate Toilet</i>	High	\$1,500
	Notes: Side wall adjacent to toilet is not smooth and includes several pipes that encroach on grab bar area. Wall needs to be only high enough to provide surface to attach grab bars (top max. 36", wall max. height needed would be approximately 40"). Toilet currently 19-1/2" from wall (16-18" req'd.), relocate toilet to compliant distance from new wall. Federal Guideline: 604.2,

<i>Provide Compliant Grab Bars</i>	High	\$1,200
	Notes: Grab bars provided are at 37-3/4" height to top of gripping surface (33-36" req'd.), side grab bar is only 36" long (42" min.), rear grab bar centered on the toilet 13-1/2"/22-1/2" (12"/24" req'd.), space between side bar and wall is 3" (1-1/2" req'd.), and side grab bar blocked by toilet paper dispenser and pipes. Federal Guideline: 308, 604.5, 609		
	<i>Reposition Toilet Paper Dispenser</i>	Low	included above
	Notes: Toilet paper dispenser is located within 12" clear space req'd. above side grab bar. Relocate to min. 1-1/2" below grab bar with centerline 7-9" in front of toilet when new wall constructed. Federal Guideline: 609.3		
	Federal Guideline: 303, 307.3, 405, 505		
	Facility Total:		\$21,770
General Notes:

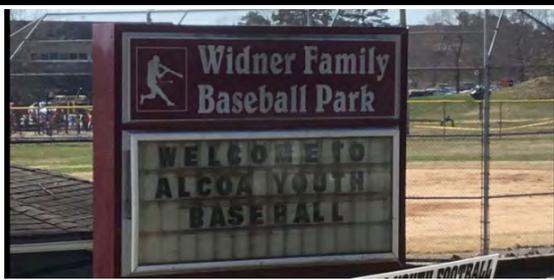
Alcoa Little League

22	<i>Site Furniture Park Area</i>		
	<i>Provide Accessible Picnic Tables to Accommodate 4 Wheelchair Spaces</i>	Low	\$800
	Notes: Several picnic tables provided within gravel areas and not located on an accessible route. 1 wheelchair space required for each 24 linear feet of usable table surface perimeter. Provide accessible picnic tables located on an accessible route. Cost includes concrete pad with 36" space around 2 picnic tables near concessions. Federal Guideline: 206.2.2, 403, 1011.4.2, 902.3, 306.3.1-3		
	<i>Provide Accessible Trash Container</i>	Low	\$100
	Notes: All trash containers located in gravel area. Cost includes additional grill trash can placed near accessible picnic tables which should be adjacent to sidewalk. Federal Guideline: 206.2.2, 403, 1011.2.1, 1016.4		
34	<i>Concessions Service Counter</i>		
	<i>Provide Accessible Service Counter</i>	Medium	\$200
	Notes: Existing service counters for concessions at 41-1/4" (36" max.). Determine alternate accommodation, which may include doorside service. Federal Guideline: 904

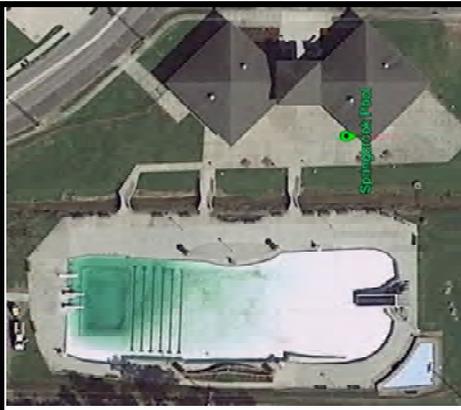
Springbrook Pool

<i>Provide Compliant Sloped Entry to Pool</i>	Medium	\$8,500
	Notes: Existing sloped entry ends in less than 24" of water depth (24-30" req'd.), the landings at the top and bottom of the ramp are not level, the running slope of the sloped entry varies up to 10.7% (8.33% max.), has handrails only on one side (req'd. on both), handrail gripping surface at 40-1/2" (34-38" req'd.) and have extensions at the bottom (req'd. only at the top, obstruct at bottom), and clear width of ramp is 48" (33-38" req'd.). Explore options to provide compliant second entry, which may be something other than sloped entry, such as transfer wall, transfer system, or stairs. Cost assumes existing sloped entry is altered and may vary depending on how renovation is done. Assumed to be concrete work with sealer and new handrails. Federal Guideline: 504.2, 504.3, 505.4, 505.10.2, 1009.6.1, 1009.6.2		
	Facility Total:		\$126,800

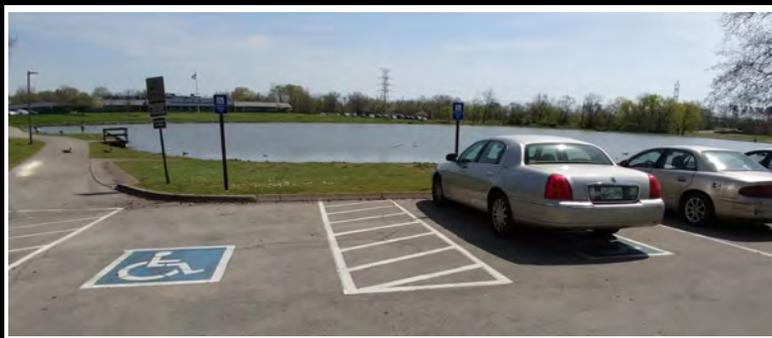
Alcoa Duck Pond

<i>Reposition Grab Bars</i>	Low	\$600
	Side grab bar extends only 48" from rear wall (54" min. req'd.). Rear grab bar centered on toilet 14"/22" (12"/24" req'd.). Federal Guideline: 604.5.1, 604.5.2		
	<i>Reposition Hand Dryer and Toilet Paper Dispenser</i>	Medium	\$250
	Notes: Both are located less than 12" clear space required above the grab bar. Toilet paper dispenser located only 5" in front of toilet (7-9" req'd.). Federal Guideline: 604.7, 609.3		
22	Site Furniture		
	<i>Provide Accessible Route and Clear Space at Bench</i>	Low	\$250
	Notes: Bench nearest restrooms does not provide a minimum clear, level space located entirely outside of the accessible route. Provide 30"x48" minimum area adjacent to bench that provides min. 36" width unobstructed access to restrooms. Federal Guideline: 903.2, 1011.2.1		
	<i>Provide Accessible Route and Clear Space at Grill</i>	Low	\$250
	Notes: Grill does not provide a minimum clear, level space 48"x 48" on all usable sides of the grill. Relocate or provide new grill to area adjacent to one of reconfigured picnic tables described above. Federal Guideline: 1011.2.1

28	Fishing Platform		
	<i>Correct Level Change</i>	Medium	\$200
	Notes: The transition from the accessible route to the platform has a 1-3/4" elevation difference (1/2" max.). Provide compliant transition that eliminates the vertical level change. Federal Guideline: 303, 403.4		
	<i>Provide Lowered Section of Railing</i>	Medium	\$500
	Notes: Fishing platforms require minimum of 25% of railings, guards, or handrails be 34" max. above the deck and 30" wide min. Entire 236" perimeter is at 38-1/2". Provide lowered section in most fishable location for wheelchair user. Federal Guideline: 1005.2.1		
	<i>Provide Barrier at Deck</i>	High	\$400
	Notes: Fishing platforms require edge protection via a curb or barrier 2" min. above the surface of the platform but also provides 9" toe clearance. Provide 2" min. barrier on all sides. Federal Guideline: 1005.3		
	Facility Total:		\$9,600
General Notes:
